BELZONA REBUILDS SPALLED BEAMS

ID: 1014

Customer Location: *Stadium, Eastern England*
Application Date: *February 2008*

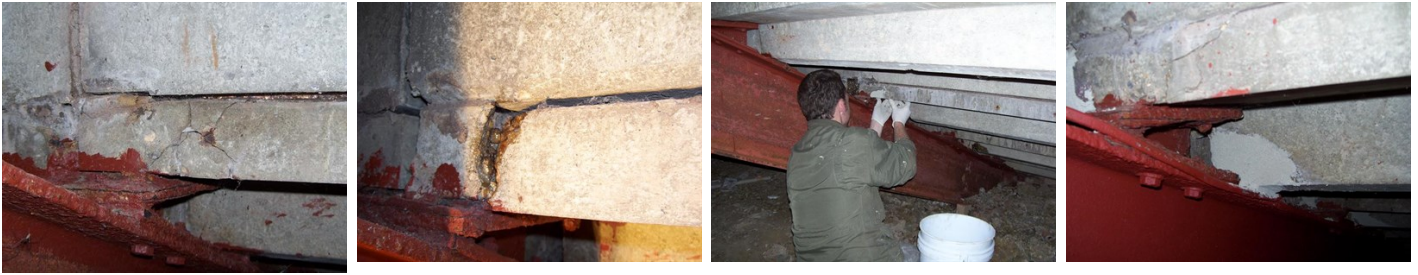
Photograph Descriptions

Spalling and cracking of concrete caused by corrosion of reinforcement bars.

- * Typical cracked area ,
- * Surface cleaned and prepared ,
- * Application in progress ,
- * One of many finished applications ,

Supporting beams under the grandstand.

Application was carried out in accordance with Belzona Know-How System Leaflet WPA-4.

After Engineers confirmed structural integrity of the stands, Architect recommended that the beams be repaired to prolong the useful life of the grandstand so Belzona were called in. The cost of repair was a fraction of the cost of any viable alternative. Belzona repairs were to provide ongoing corrosion protection to rebar and more than 60 individual faults were fixed.
