Brass Impeller repair and coating

ID: 10149

Application: PDP-Positive Displacement Pumps

Application Date: December 2025

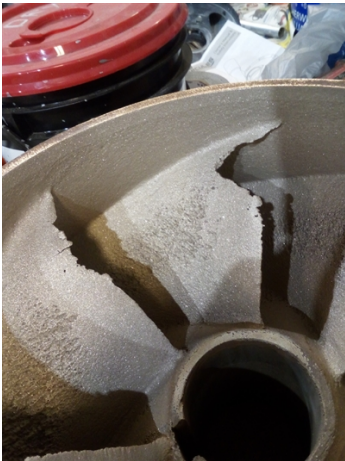
The client took a pump out of service for inspection and found several problem areas. The impeller being one of them. The leading edges were worn almost half way off.

Notice leading edge of impeller blades

We began by blasting to a 3 mil profile then cleaning the surface with 100% MEK. Followed by our crafty applicator repairing the leading edges with Belzona 1111. We completed the application with two coats of Belzona 1321.

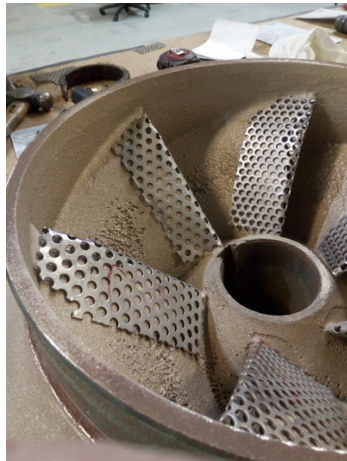
Giving this impeller back its leading edges

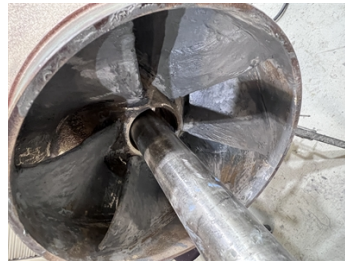
After Belzona 1111 metal repair

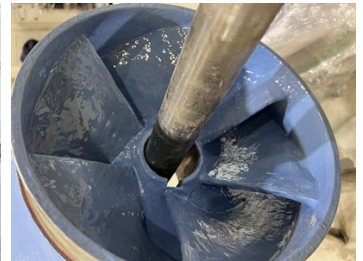
After two coats of Belzona 1321
