# Party Supplier In Need of Belzona

ID: 10155

Industry: Commercial Facilities  
Application: FPA-Floor Problem Areas  
Substrate: Concrete  
Products: Belzona 4124 (Bulkfill), Belzona 4131 (Magma-Screed), Belzona 4911 (Magma TX Conditioner)

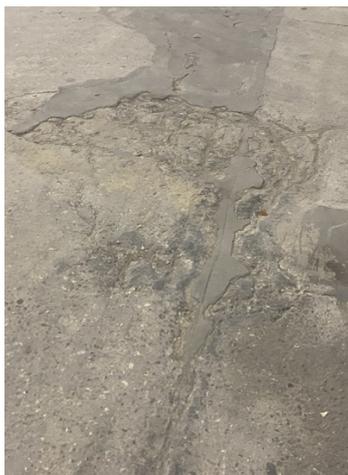
The surface of the concrete floor had become damaged due to heavy forklifts traffic and impact from heavy pallets being loaded and unloaded. The uneven surface was making it increasingly difficult for the the safe operation of their busy schedule.

Damaged sections of the floor

After surface preparation, the area was conditioned with Belzona 4911

The area was filled with Belzona 4124 except for the top 1/4 inch

Top 1/4 inch was filled with Belzona 4131

The application was completed in accordance with Belzona Know-How System Leaflet FPA-1. The concrete ramp was grinded down until safe and sound on concrete was found. The Belzona floor repair system was applied to the damaged area without interruptions.
