# Flue Gas Compressor Index Cover Repair and Coating with Belzona

ID: 10168

Substrate: Cast Iron  
Products: Belzona 1391T, Belzona 1511 (Super HT-Metal)

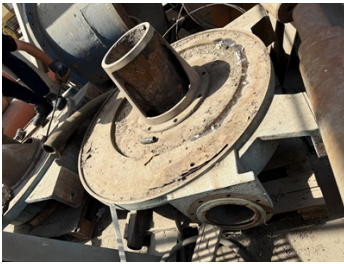
## Problem

Eroded pump cover

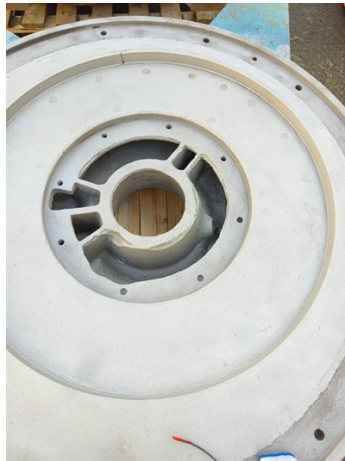
Surface preparation carried out by grit blasting

The pump cover was grit blasted to remove corrosion and achieve the minimum required surface profile. The eroded areas were rebuilt using Belzona 1511 (Super HT-Metal). A two-coat system of Belzona 1391T was then applied to provide long-term protection against erosion and corrosion.

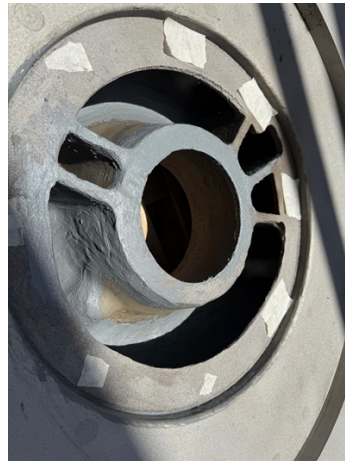
Surface rebuilt using Belzona 1511 (Super HT-Metal)

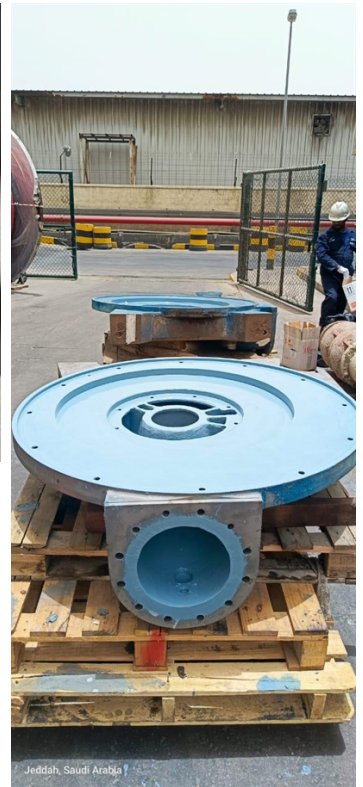
Pump cover coated with Belzona 1391T
