# BELZONA RAPID FLOOR REPAIR

ID: 1018

Customer Location: Box manufacturer, Montgomery,  
Alabama USA

Application: FPA-Floor Problem Areas

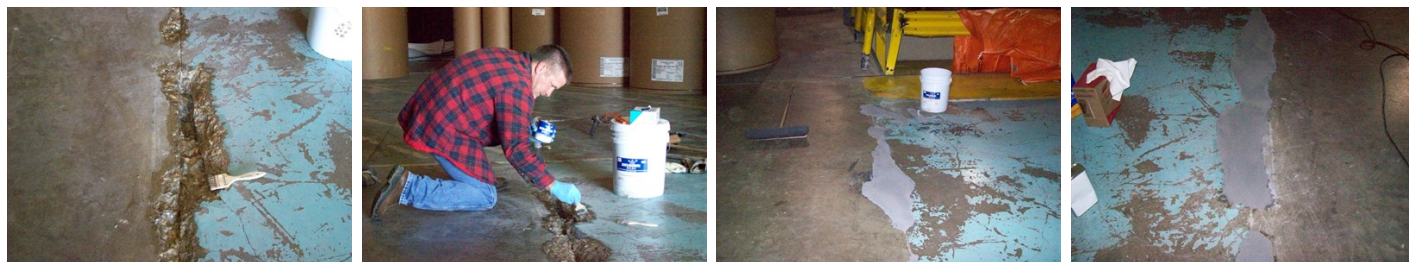
## Photograph Descriptions

Hole in floor creating problem for fork lift drivers loading and unloading cardboard for box manufacture.

\* Removed concrete from hole , \* Belzona® 4911 being applied , \* & 4. Finished application ,

Application was carried out in accordance with Belzona Know-How System Leaflet FPA-1.

The alternative was to saw cut concrete and pour new concrete. That would be more costly because of labor and down time in the area. It was possible to drive over the Belzona applied in morning that night.
