## Safety nonskid for office entry

ID: 10183

Application: FPA-Floor Problem Areas

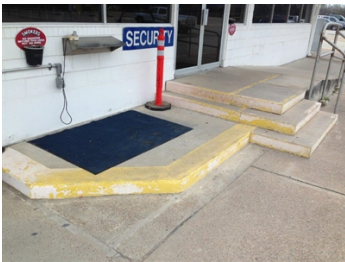
Worn Belzona 5231 areas from an application applied in January of 2000.

The surface was prepared by power washing to remove any loose coatings as well as dirt and debris. A diamond grinder was used to abrade the surface to provide an acceptable substrate. The first coat of 5231 was applied, then 9221 was broadcasted in for nonskid properties. A second coat of 5231 was applied within the overcoat window in accordance with the Belzona instructions for use.

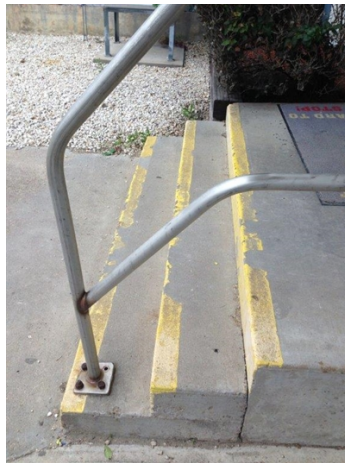
14 year old non-skid application.

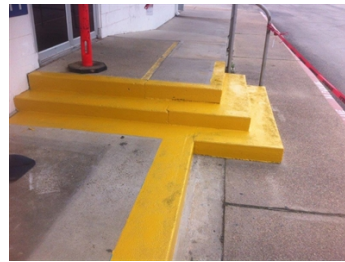
Areas refreshed with Belzona 5231 and 9221 Surefoot aggregate.

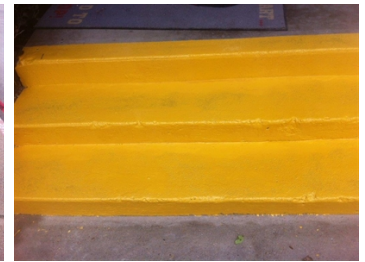
Refreshed and ready for another 14 years of service.
