# BELZONA SEAL TO DRYER CAN SAVES MONEY

ID: 1019

Customer Location: Paper Co. Jackson, Alabama

Application: GSS-Gaskets, Seals and Shims

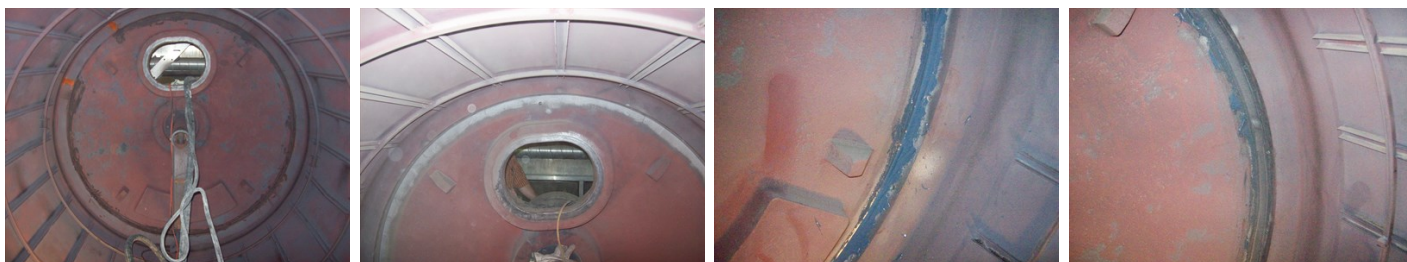
## Photograph Descriptions

Gasket of dryer can failed and allowed steam to escape. Losing steam means losing money.

\* Start of job , \* Surface around joint grit blasted , \* Application of Belzona® 1321 , \* Application of Belzona® 1311 to complete the repair ,

Application was carried out in accordance with a modified Belzona Know-How System Leaflet GSS-6. After grit blasting, a 2" band of Belzona® 1321 brush applied followed by Belzona® 1311 pressed firmly into the seam where the gasket had failed.
