# BELZONA REBUILD OF CORRODED RUDDER STOCK

ID: 102

Industry: *Marine*  
Application: *SOS-Ships and Offshore Structures*

Customer Location: *Merchant vessel, France*  
Application Date: *1995*

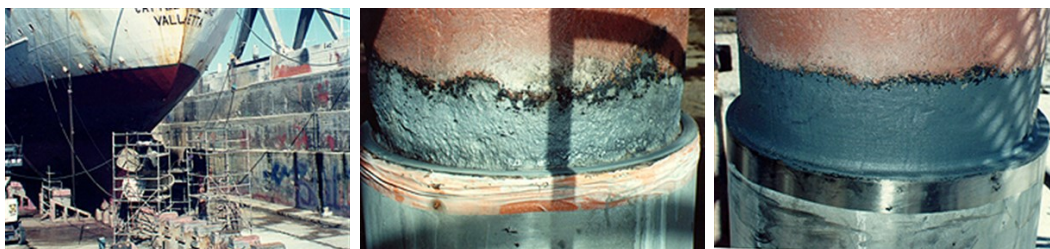
## Photograph Descriptions

*Severe erosion-corrosion caused by galvanic corrosion*

- \* Work underway on the vessel in dry-dock ,
- \* The seal face of the liner was masked before grit blasting ,
- \* Completed application ,

Junction of stainless steel liner on rudder stock

Application was carried out in accordance with Belzona System Leaflet SOS-1.

The excellent corrosion resistance of Belzona® 1111 and its insulation characteristics made it the ideal choice for long term protection in this area. It was a Bureau Veritas specification.
