BELZONA REPAIRS RUBBER LINED BRINE TANK

ID: 1020

Industry: *Pulp & Paper*
Application: *TCC-Tanks and Chemical Containment Areas*
Substrate: *Steel and Rubber*
Products: *Belzona® 2111 (D&A Hi-Build Elastomer)*

Customer Location: *Paper Mill, Alabama*
Application Date: *February 2008*

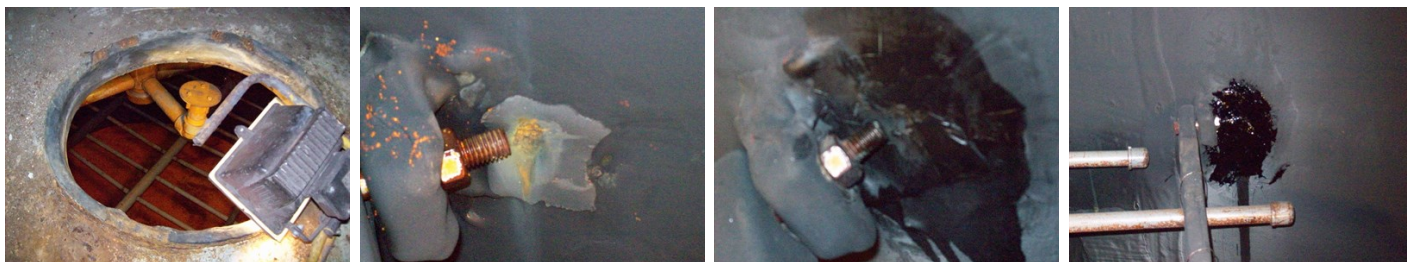
Photograph Descriptions

Rubber lining had been damaged locally. It was too costly to get specialist tank repair company to come and make repair.

* Opening to the tank , * Exposed metal where repair to be made , * Conditioner applied after grinding , * Repair completed with Belzona® 2111 ,

Application was carried out in accordance with the Belzona Know-How System Leaflet TCC-3.

Would have cost over \$2500 for specialist tank company to come make the repair. Used one unit of Conditioner and one unit of Belzona® 2111. Repair was made one day and tank was put back in surface the next day.
