# Gypsum dust blower 7111

ID: 10205

Industry: Mining & Quarrying  
Application: GSS-Gaskets, Seals and Shims  
Substrate: Concrete  
Products: Belzona 7111

Customer Location: Oklahoma  
Application Date: January 2026

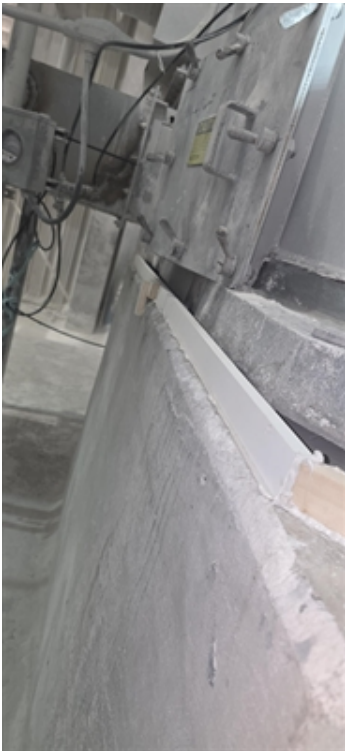
A wooden containment was built around the area that we were planning to use 7111. This was regular with bought from Home Depot

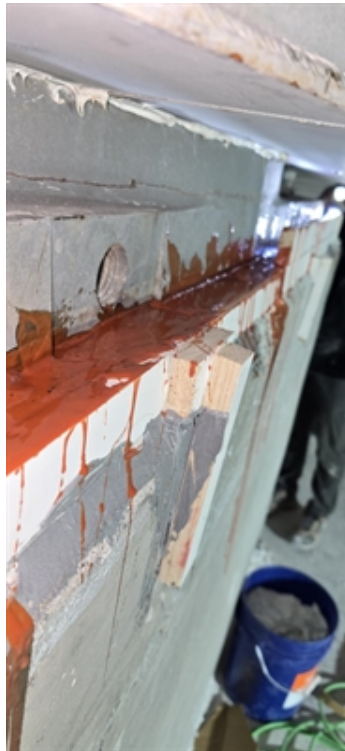
This picture was taken straight after pouring was complete

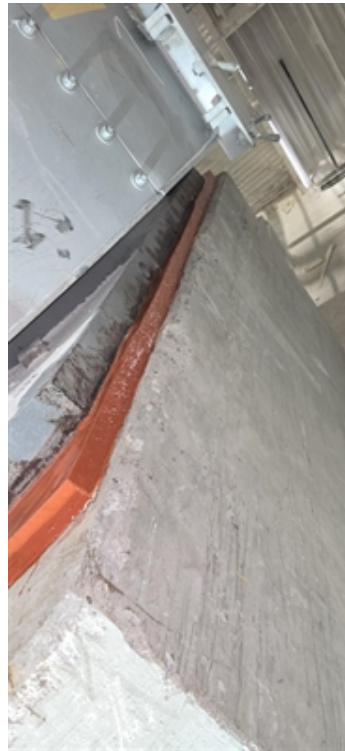
Picture was taken the next day after 7111 was allowed to fully cure out and boards were removed
