# Protection of floor and walls in a storage room for oil and lubricants with Belzona coatings

ID: 10210

Application: FPA-Floor Problem Areas

Products: Belzona 5231 (SG Laminate), Belzona 5811 (Immersion Grade)

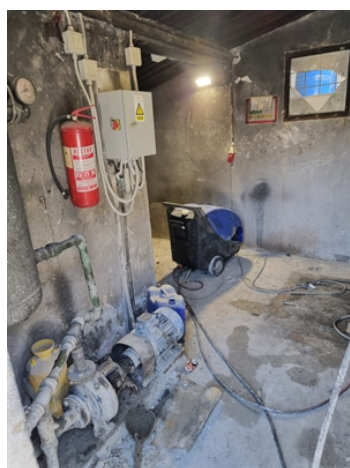
Situation before application.

Walls and floor of an oil and lubricants storage room were uncoated, which caused permanent dirtiness and greasiness as well as unpleasant odor in the room. Such conditions in the room were unfavorable for employees and the first signs of deterioration of the concrete started to appear so a repair was required..

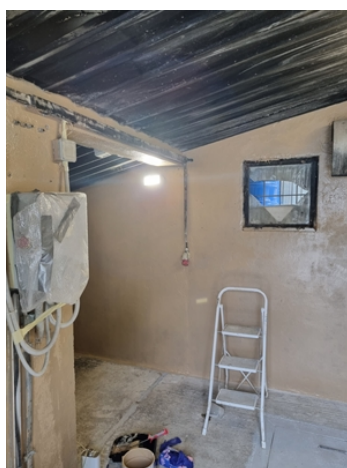
Coating of walls with Belzona 5811.

Application was carried out in accordance with Belzona Know-How System Leaflet FPA-3 (applied to both walls and floor). Surfaces were grinded using mechanical grinders and thoroughly washed with pressurized water and detergent in order to remove settled impurities. One coat of Belzona 5811 on the walls and two coats of Belzona 5231 on the floor were applied. During application of the first coat on the floor, Belzona 9221 (Surefoot) Aggregate was added in order to achieve anti-slip surface. It was later covered with second coat of Belzona 5231 to make cleaning of the room easier.

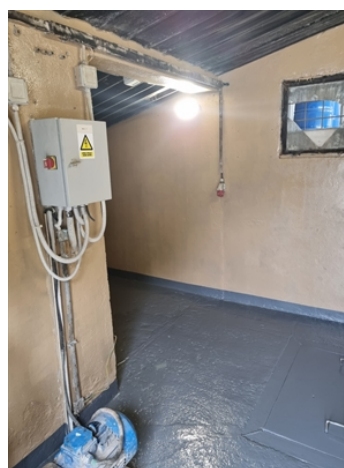
Application finished on both walls and floor.

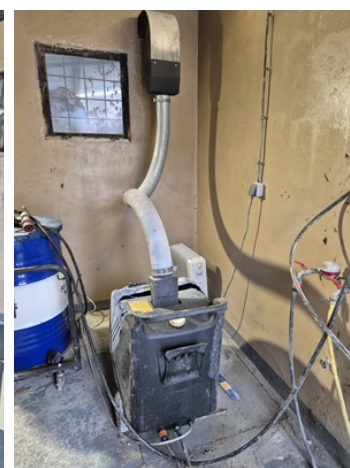
Situation after 2,5 years – coatings are still in good condition.
