Concrete pump plinths repaired with Belzona

ID: 10251

Industry: Water / Wastewater
Application: FPA-Floor Problem Areas
Substrate: Concrete
Products: Belzona 7111

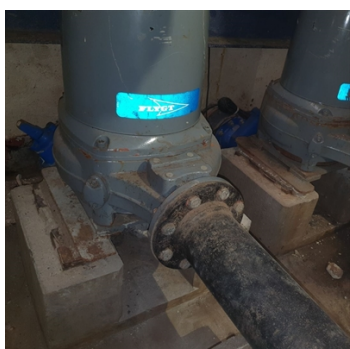
Concrete plinths had been worn away due to vibration from pumps

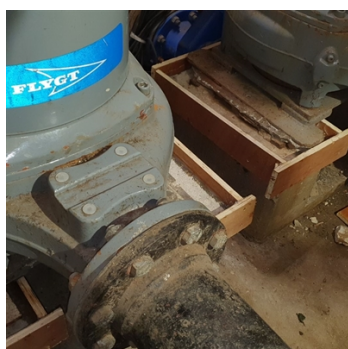
The plinths required a long term durable solution that can withstand the effects of constant vibration

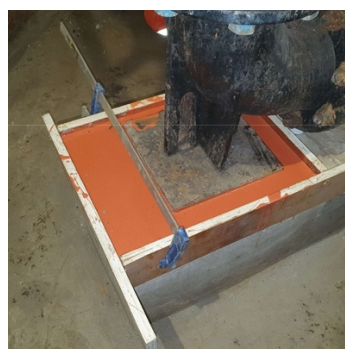
The shuttering is applied around concrete plinths and Belzona 7111 is poured into the recess

After carrying out a site survey, Belzona 7111 Chocking compound was recommended for the repair of the five plinths. All loose concrete was removed back to solid concrete. Shuttering was cut to size, coated with a release agent and assembled around the plinths. Belzona 7111 was mixed and poured into the dammed voids and allowed to cure. Once cured, shuttering was removed.

Rebuilding of the plinths was performed in accordance with leaflet (FPA-01). Manual hand tools were used to remove loose debris and the shuttering was treated with a release agent. Belzona 7111 was poured into the shuttering.

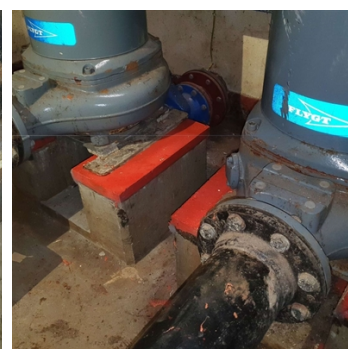
Belzona 7111 is cured and the plinths now have a durable base for the pumps
