BELZONA REBUILDS LINER SEAL GROOVES

ID: 1026

Main diesel engine cylinder liner 700 mm diameter

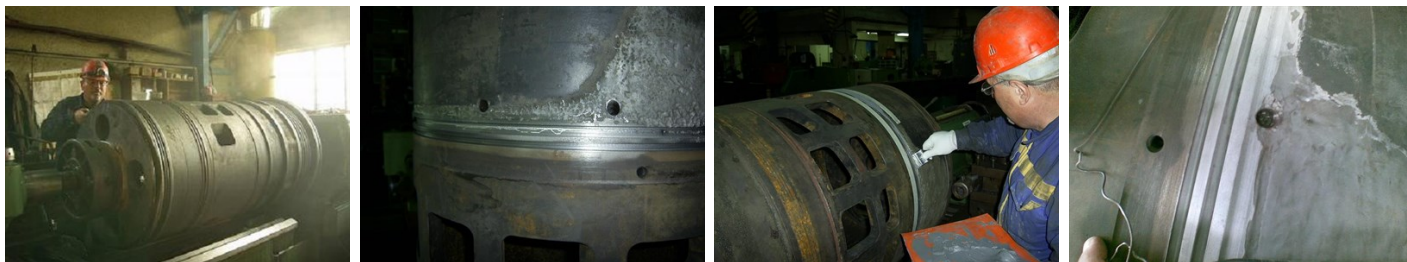
Photograph Descriptions

Severe pitting corrosion on the liner body and damaged seal grooves

* The liner on the lathe , * Severe pitting corrosion clearly evident after grinding and blasting , * Application of Belzona® 1111 on the seal grooves in progress , * Seal grooves machined down on the lathe to restore original profile ,

Application was carried out in accordance with Belzona Know-How System Leaflet ENC-5.

Belzona saved more then 12,000 USD in replacement costs and downtime. Belzona provides a quick and cost effective corrosion resistant repair without heat.
