# Belzona System Restores Pipeline Header

ID: 10269

| Industry: | Power | Customer Location: | Ulsan, Gyeongsangbuk-do |
| Application: | VPP-Valves, Pipes and Fittings | Application Date: | January 2026 |

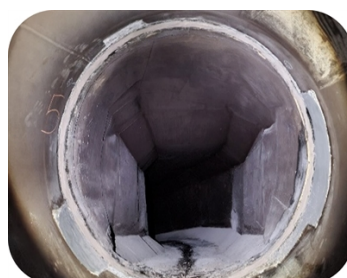
Damaged surface was rebuilt with Belzona 1111 (Super Metal) and Belzona 4131 (Magma-Screed)

Belzona 1111 (Super Metal) was used to rebuild damaged areas, while Belzona 4131 (Magma-Screed) strengthened the repair against mechanical and chemical damage. Final protection was achieved with Belzona 5811 (Immersion Grade) and Belzona 5831 (ST-Barrier) in standing water areas.

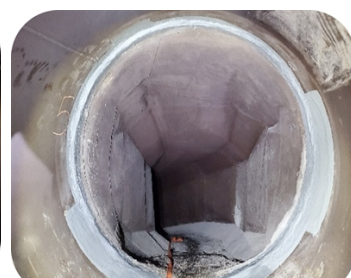
Final coating using a two-coat system of Belzona 5811 (Immersion Grade)
