# Belzona Immersion Coating Used in Heat Exchanger Water Box

**Industry:** Power  
**Application:** HEX-Heat Exchangers  
**Substrate:** Carbon steel  
**Products:** Belzona 1111 (Super Metal), Belzona 5811 (Immersion Grade)

**Customer Location:** Gyeongsangbuk-do, South Korea  
**Application Date:** January 2026

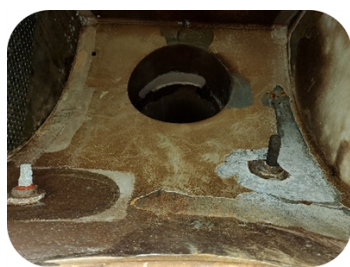
The existing coating on the carbon steel heat exchanger water box had deteriorated over time due to aging, continuous operation, and exposure to foreign matter within the system. The loss of coating integrity led to surface corrosion and contamination, increasing the risk of further degradation and reduced equipment reliability. As the heat exchanger operates within a nuclear power plant system, restoration of the protective barrier was required to maintain long-term asset protection and operational performance.

Heat exchanger water box was found damaged as the existing coating had failed

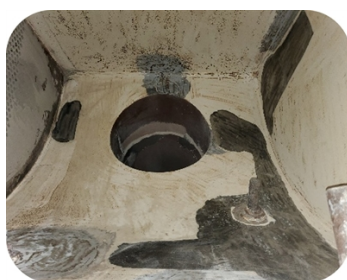
Power tools were used for surface preparation and to remove all loose materials

1. The deteriorated and contaminated coating was removed to ensure proper surface preparation and long-term repair performance.
2. Belzona 1111 (Super Metal) was applied to rebuild and restore the damaged areas of the carbon steel heat exchanger water box.
3. After the repair material had fully cured, two coats of Belzona 5811 (Immersion Grade) were applied to provide corrosion and moisture protection under intermittent wet service conditions.

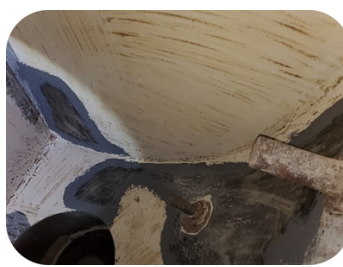
Belzona 1111 (Super Metal) was applied to rebuild the surface

The failed coating and loose materials were removed from the heat exchanger water box before surface rebuilding was carried out using Belzona 1111 (Super Metal). Due to intermittent moisture exposure during operation, Belzona 5811 (Immersion Grade) was selected and applied to provide long-term corrosion and moisture protection for the carbon steel surface.

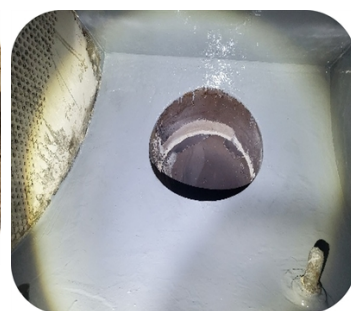
Belzona 5811 (Immersion Grade) was applied to protect the water box from immersed condition
