# Belzona SuperWrap II Reinforced Leak Sealing on 10-inch Valve

ID: 10280

| Industry: | Power | Customer Location: | Yeonggwang, South Korea |
| Application: | VPF-Valves, Pipes and Fittings | Application Date: | February 2026 |

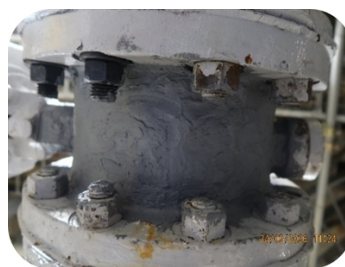
Belzona paste-grade materials, suitable for emergency repair, seal the leak on the valve

Leakage was identified on the external surface of the piping system as a result of corrosion and pipe wall degradation caused by aging. To immediately stop the leakage, Belzona 1212 and Belzona 1221 (Super E-Metal) were used to seal the affected area. These materials are suitable for high-speed emergency repair.

1. Hand tools were used to remove rust and prepare the surface for application of paste-grade materials to seal the leak.
2. Belzona 1221 (Super E-Metal) and 1212 were applied to the leakage area as they are suitable for emergency repair.
3. Belzona 1111 (Super Metal) was then used for rebuilding the valve geometry and left to cure.
4. Belzona SuperWrap II was applied on top of the Belzona 1111 (Super Metal) to reinforce the protective protocol for the valve
