# Belzona Leak Sealing and Reinforcement Work on Condenser Waterbox Outlet

ID: 10282

Customer Location: Taean Si, South Korea  
Application Date: January 2024

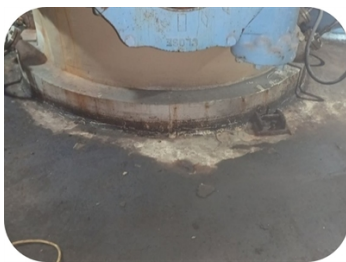
The lower section of the condenser waterbox outlet suffered severe corrosion and wall penetration due to continuous exposure to seawater and other corrosive media. The deterioration caused leakage, resulting in reduced structural integrity, operational inefficiencies, damage to surrounding equipment, and potential environmental contamination.

Damaged on the lower section of condenser waterbox

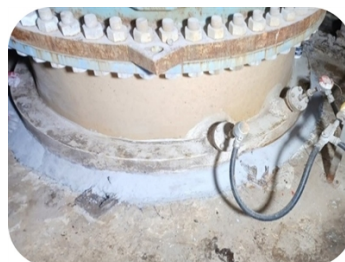
Belzona 4111 (Magma-Quartz) rebuilt the damaged concrete at the lower section of the condenser waterbox outlet

Concrete substrate of the lower section of the condenser waterbox outlet was rebuilt with Belzona 4111 (Magma-Quartz) to stop the leak.

1. Power tools were used for surface preparation and to remove all loose contaminants from the concrete at the lower section of condenser waterbox outlet.
2. Apply Belzona 4911 (Magma TX Conditioner) to ensure the optimum adhesion of Belzona 4111 (Magma-Quartz).
3. Mix Belzona 4111 (Magma-Quartz) until the desired consistency was achieved and then apply the mixed material to build up the base of the waterbox.
4. Once cured Belzona 5811 (Immersion Grade) was applied as a two-coat system to protect the concrete.

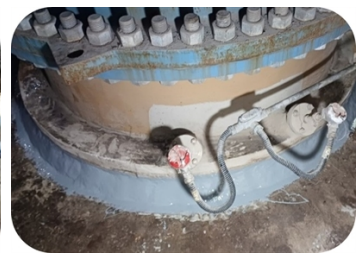
Belzona 5811 (Immersion Grade) coated on the rebuilt concrete at the lower section of the condenser waterbox outlet

To further protect the target area, Belzona 5811 (Immersion Grade) was applied as a coating to protect concrete and prevent leakage caused by exposure to moisture, and other environmental and operational factors.
