# Belzona Protects 165 MW Hydroelectric Generating Unit from Erosion-Corrosion and Cavitation Damage

**Industry:** Power  
**Application:** VPF-Valves, Pipes and Fittings  
**Substrate:** Carbon steel  
**Products:** Belzona 1161 (Super UW-Metal), Belzona 1212, Belzona 1321 (Ceramic S-Metal), Belzona 1331

**Customer Location:** Pantabangan, Nueva Ecija, Philippines  
**Application Date:** May 2021

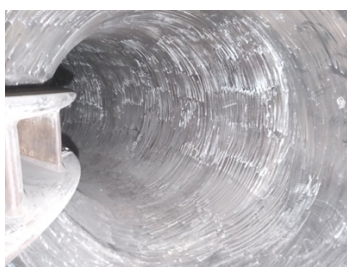
Continuous exposure to high-velocity water flow and entrained particles caused erosion-corrosion and cavitation damage on critical waterways components of Unit 1 at a hydroelectric power plant. The deterioration was evident on the spiral casing, stay vanes, guide vanes, turbine runner, draft tube cone, and draft tube wall, threatening hydraulic efficiency, equipment reliability, and long-term operational performance.

Erosion-corrosion and cavitation damage identified on the turbine waterways prior to repair.

The affected surfaces were inspected and mechanically prepared by power grinding to remove contaminants, oxidation, deteriorated coatings, and damaged material. Surface preparation was carried out in accordance with approved procedures to achieve a clean and firm substrate suitable for coating application. Belzona 1212 and Belzona 1161 (Super UW-Metal) were applied to rebuild damaged areas and provide a surface-tolerant foundation for subsequent coatings. Belzona 1321 (Ceramic S-Metal) was then applied to stay vanes, guide vanes, draft tube cone, draft tube wall, and turbine runner areas requiring enhanced erosion-corrosion and cavitation resistance. Belzona 1331 (Ceramic R-Metal) was applied to the spiral casing operating under continuous immersion conditions. Additional coating thickness was applied to leading edges and high-wear zones to maximize
