# Belzona Repairs Scupper on a Navy Vessel

ID: 10287

Industry: Military  
Application: FPA-Floor Problem Areas  
Substrate: Carbon steel  
Products: Belzona 5831 (ST-Barrier)

Customer Location: Devonport, New Zealand  
Application Date: April 2026

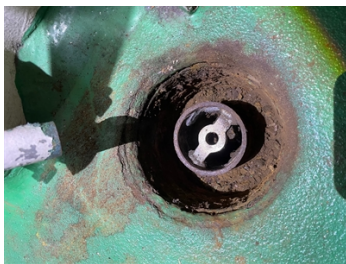
*The scupper aboard this particular vessel is exposed to salt water and had become badly corroded, if the corrosion had been allowed to progress further then the scupper may have begun to leak and salt water could have penetrated into the lower decks of the ship causing structural damage which would have necessitated time consuming and expensive repairs*

The original condition of the scupper

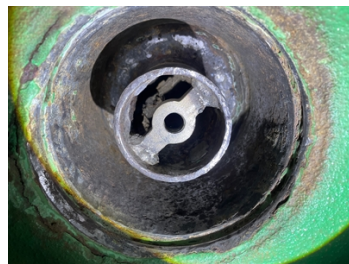
After surface preparation with a power file

A power file and abrasive paper was used to reach inside the scupper and remove as much of the corrosion as was possible. This was then vacuumed out. Solvent was used to wash the prepared substrate to remove any dust / oil or grease that may have remained.

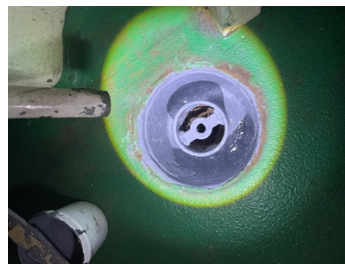
Two coats of Belzona 5831 (ST-Barrier)

Belzona 5831 (ST-Barrier) was mixed and applied using a radiator brush and a mirror to ensure that the entire scupper was coated. The first coat was scrubbed into the prepared surface with a circular scrubbing motion to ensure the best possible adhesion. The second coat was applied with care to ensure that there would be no pinholes or thin DFTs and that the finish would be aesthetically pleasing.

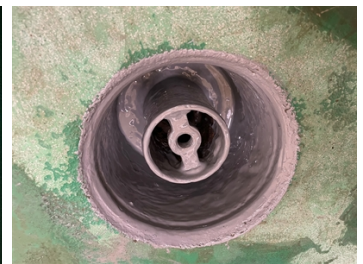
Condition of the scupper after 1 month in service
