# Surface Tolerant Deck Repair with Belzona

ID: 10288

Industry: Marine  
Application: FPA-Floor Problem Areas  
Substrate: Carbon steel  
Products: Belzona 1161 (Super UW-Metal)

Customer Location: Devonport, New Zealand  
Application Date: April 2026

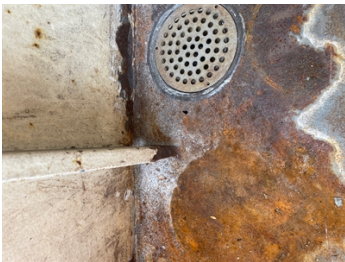
*Due to misalignment of the scupper drain, salt water had ponded in the corner of a storage locker and caused localized pitting and penetrations in the deck. This was causing water to leak through the deck and into the ship. Left unchecked this leak would have caused thousands of dollars of damage and allowed water through to the lower decks which could have affected normal operations and was an unacceptable hazard for the client.*

The scupper rim had been installed proud of the surrounding deck allowing water to pond around it and corrode through the deck

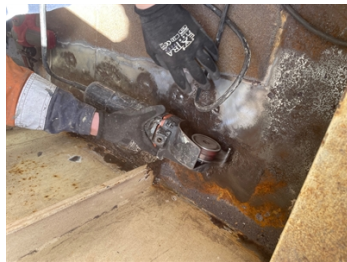
MBX preparation ensured that there was minimal noise and dust produced during surface preparation

Surface preparation was carried out with flap discs and an MBX to ensure cleanliness and profile in-line with the SP11 Specification. The holes were patched with Belzona 1161 (Super UW-Metal) with incorporated Belzona 9341 reinforcement tape. The whole repair area was then wet-out with Belzona 1161 (Super UW-Metal) and built up until proud of the drain. Once cured, sanding made the repaired area smooth and ready for painting.

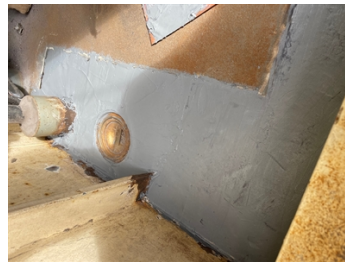
Belzona 1161 (Super UW-Metal) was used to reclaim pitting and holes in the deck, then applied in a thicker layer to raise the height of the deck to ensure good drainage in future.

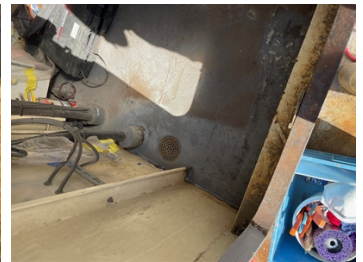
3 weeks after completion the area is draining as intended and the risk of further corrosion has been greatly reduced.
