# Pallet Drone Storage and Charging Area repaired and protected with Belzona 5821

ID: 10290

| Application: | FPA-Floor Problem Areas | Application Date: | May 2026 |

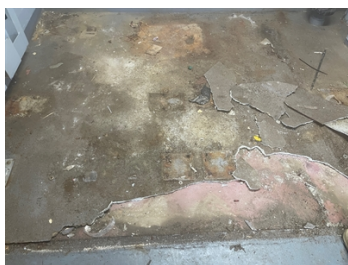
The previous paint system was unable to withstand the aggressive conditions and had failed

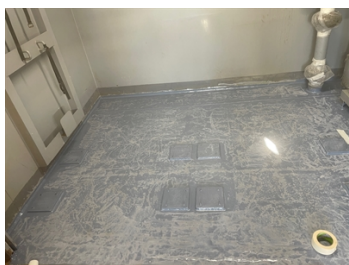
Pitting in the floor was reclaimed with Belzona 1161 (Super UW-Metal). A first coat of Belzona 5821 was then applied over the top and allowed to cure over the weekend. This first coat was abraded prior to applying a second coat of Belzona 5821 on Mon

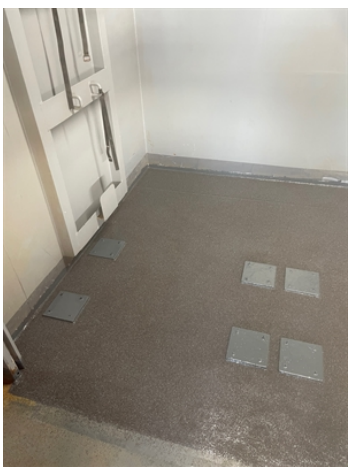
The second coat of Belzona 5821 was broadcast with Belzona 9231 (Surefoot aggregate) to ensure a non-slip surface.

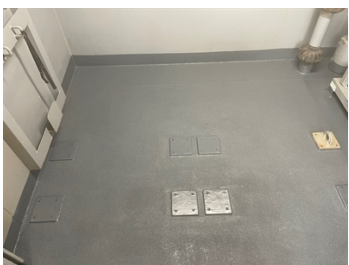
A final topcoat of Belzona 5821 was applied over the Surefoot, to encapsulate the grip system for ease of cleaning as per the wishes of the client.
