# Pipework protection at a clean water site with Belzona 5831

ID: 10291

Industry: Water / Wastewater  
Application: VPF-Valves, Pipes and Fittings  
Substrate: Carbon steel  
Products: Belzona 5831 (ST-Barrier)

Customer Location: Bradford  
Application Date: June 2026

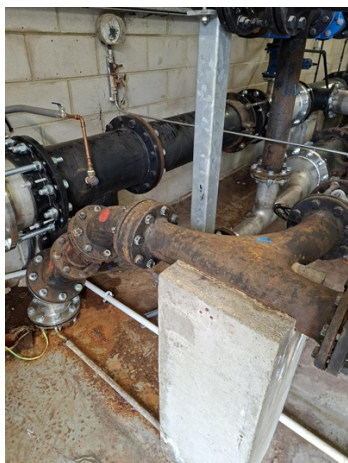
Pipework exhibiting surface corrosion due to ongoing condensation and moisture exposure

Surface preparation using power tools. Cleaning of prepared surfaces to remove contaminants and debris. Application of two coats of Belzona 5831 (ST Barrier) in accordance with manufacturer guidelines. Full coverage applied to pipework, including bolts and flanges. Coating selected for its suitability in condensation-prone environments

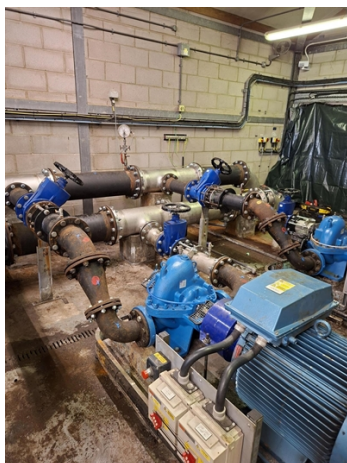
Degraded external surfaces showing clear signs of corrosion under challenging atmospheric conditions

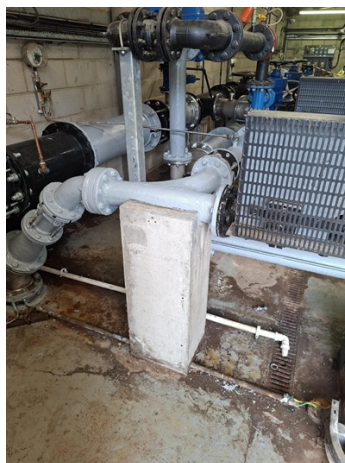
Completed application of protective coating system, restoring and protecting the pipework

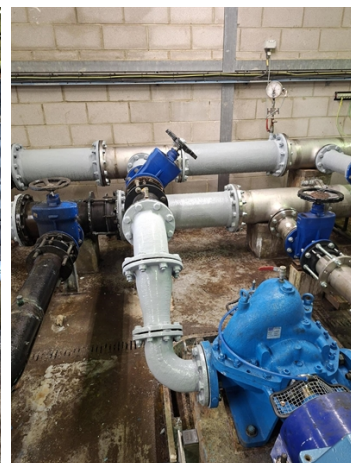
Pipework successfully protected with a corrosion-resistant coating, ensuring long-term durability
