# Belzona rescues 3.1m diameter evaporator tube sheet

ID: 10293

Industry: Sugar  
Application: HEX-Heat Exchangers  
Substrate: Carbon steel  
Products: Belzona 1511 (Super HT-Metal), Belzona 1593

Customer Location: Newark UK  
Application Date: June 2026

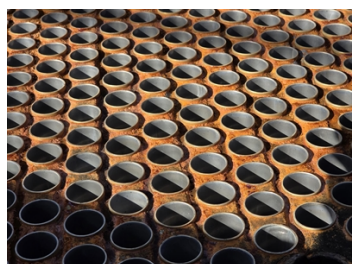
The customer presented the top tube sheet of a large evaporator for assessment while the unit remained in situ. Manufactured from mild steel, the tube sheet was 3,100 mm in diameter and between 30 mm and 35 mm thick. The tube sheet was heavily corroded, with significant pitting and wear across its surface. It housed an estimated 2,000 tubes, each 32 mm in diameter. The evaporator processes raw beet juice at 4 bar and operates at a temperature of 120°C.

Initial condition of the tube sheet

The tube sheet had suffered extensive corrosion and required a long-term repair solution. While several options were considered, the customer selected Belzona UK to provide an alternative. One option was the complete replacement of the tube sheet, which was estimated to cost approximately half a million pounds.

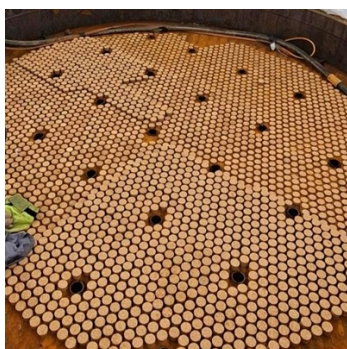
Corks fitted and ready for Grit Blasting, prior to filling with Belzona 1511

Access to the work area was established and a temporary enclosure erected to provide a controlled working environment. All equipment and materials were then safely hoisted to the work platform, located approximately 21 metres above ground level. Cork plugs were installed into the 32 mm tubes to protect them during the surface preparation process. The entire tube sheet was then grit blasted in accordance with the Belzona 1511 Instructions for Use, ensuring the required surface profile and cleanliness.
