# Emergency Belzona Repair on a 92" Circulation Pipe

ID: 10294

Industry: Power

Application: VPF-Valves, Pipes and Fittings

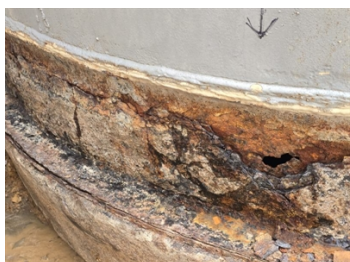
*This 92" cooling tower circulation pipe had developed severe corrosion at ground level resulting in a 1"+ hole, as well as lesser corrosion all the way around. The customer was forced to shut down operations due to the size of the leak. This section of pipe is well supported, but where the corrosion was, is where it is set on the underground concrete portion of the system.*

Original condition, including the biggest through-wall defect.

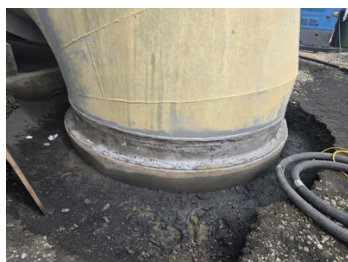
Abrasive blasting completed.

The surface was abrasive blasted to the proper profile and Belzona 1111 was applied over the rough surface to smooth it out so the Belzona SuperWrap II could be applied properly. All the Belzona materials were applied using the tools provided with the materials.

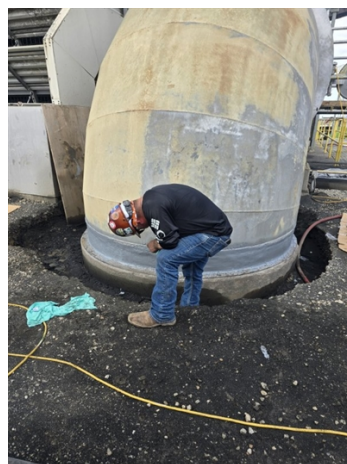
Belzona 1111 applied to the corroded area.

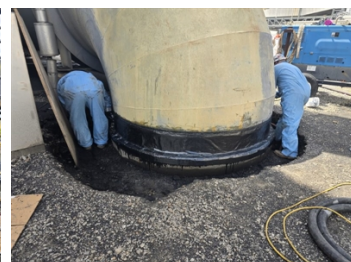
Belzona SuperWrap II system almost completely applied.

The quick turnaround of a 24 hour cure after the application was completed was perfect for this emergency situation. There was no other alternative considered as Belzona has been a proven solution at this facility for several years, including many in-house application of the Belzona SuperWrap II system.
