# Belzona Abrasion and Erosion Resistant System in a Circulating Water Pipe

ID: 10296

**Industry:** Power

**Application:** VPF-Valves, Pipes and Fittings

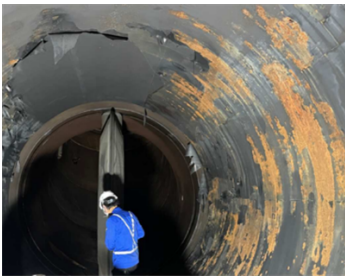
At a power plant in Central Java, Indonesia, rubber lining in circulating water (CW) pipeline spool have failed in early year of operations, due to wrong applications and potentially high flowrates of seawater. After one year of repair on the lining using an elastomeric material, the customer sought a repair for the entire piping system for a long-term protection.

Rubber lining damage in a circulating water pipe

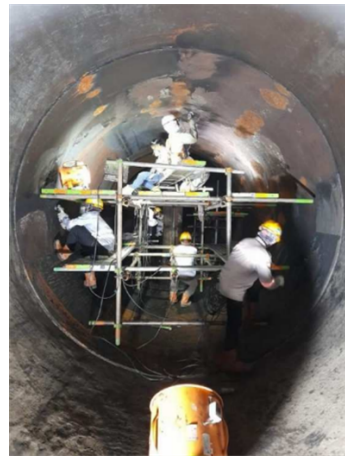
Rubber lining was removed before the application of a more permanent abrasion and erosion resistant system

The first phase of the application used Belzona 2221 (MP Fluid Elastomer) to repair damaged rubber linings of the spool. One year after the rubber lining repair, the EPC company was seeking a more permanent solution for the entire area of the pipe. Thus, the rubber linings were removed before applying Belzona 1331 to create an erosion barrier for the circulating water pipe.
