# Oil Leak Repair on a Transformer Using Belzona Surface-Tolerant System

ID: 10298

**Industry:** Power  
**Application:** VPF-Valves, Pipes and Fittings  
**Substrate:** Carbon steel  
**Products:** Belzona 1161 (Super UW-Metal), Belzona 5831 (ST-Barrier)

**Customer Location:** New South Wales, Australia  
**Application Date:** April 2026

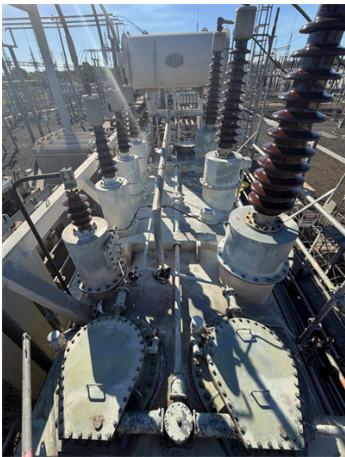
The scaffold has been erected around the transformer

1. The transformer was drained, scaffolded, and high-pressure hot washed prior to the applicators' arrival.
2. Abrasive blasting was carried out on the main transformer lid, flange, and bolts, as well as the three individual lids, including their flanges and bolts.
3. The prepared areas were prewashed with FP29 Safe Solvent.
4. All bolts (top and bottom) were sealed using Belzona 1161 (Super UW-Metal).
5. After an overnight cure, the Belzona 1161 (Super UW-Metal) was whip/frost blasted.

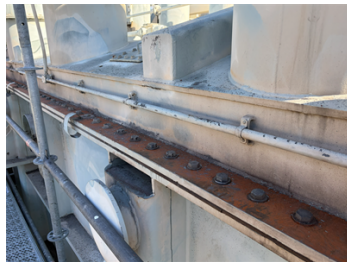
The transformer was drained and high-pressure hot washed prior to the applicators' arrival.

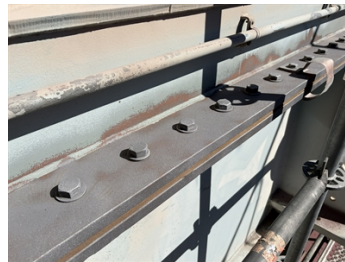
Abrasive blasting carried out on areas requiring repairs

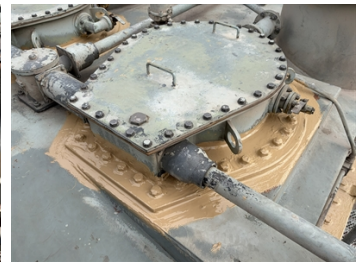
Complete application with Belzona 5831 (ST-Barrier) as a protective coating

6. The following day, the main flange was sealed using Belzona 1161 (Super UW-Metal) reinforced with Belzona 9341 Reinforcement Sheet.
7. Belzona 5831 (ST-Barrier) was then applied as a coating to complete the protective system.
8. The repair system was left to cure for 48 hours before the transformer was returned to service.
