# Drainage Pit Restoration

Application: TCC-Tanks and Chemical Containment Areas

Substrate: Concrete

Products: Belzona 4311 (Magma CR1), Belzona 4911 (Magma TX Conditioner)

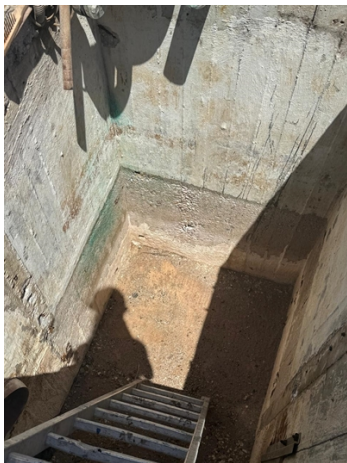
The customer was experiencing deterioration of a concrete drainage pit caused by continuous exposure to water, cleaning chemicals and general service conditions. The degraded concrete surface had become vulnerable to further damage, increasing the risk of chemical ingress, accelerated deterioration and higher maintenance costs. The customer required a durable, chemically resistant solution that could be applied during a planned shutdown, restoring the integrity of the concrete while providing long-term protection and minimizing future maintenance requirement

original condition of pit

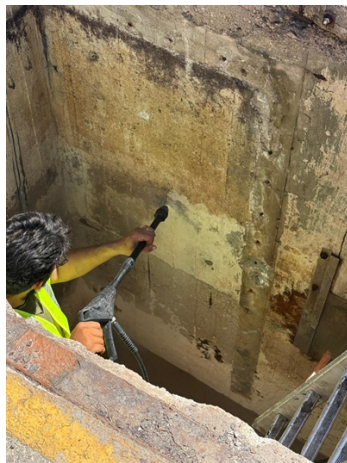
During surface preparation

The drainage pit was initially cleaned using a high-pressure water jet to remove dirt, contaminants and loose material. The concrete surface was then mechanically abraded using a grinder to achieve a clean, sound substrate suitable for coating application. After surface preparation, Belzona 4911 (Magma TX Conditioner) was applied by brush as the primer. Once the primer had cured to the appropriate stage, Belzona 4311 (Magma CR1) was applied by brush and roller to the specified thickness, ensuring complete and seamless coverage of all concrete surfaces.

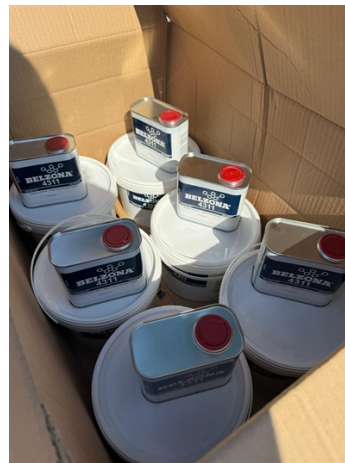
Storage of materials
