BELZONA IN-SITU REBUILD OF DECK WINCH

ID: 103

Customer Location: Liquefied Natural Gas Carrier, France
Application Date: 1997

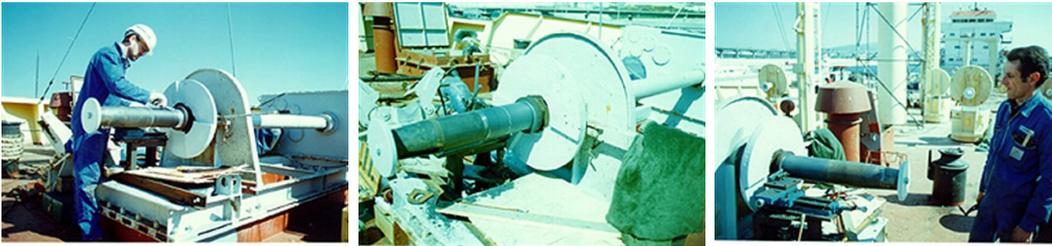
Photograph Descriptions

Wear on shaft was in the way of the cable drum

- * Belzona® 1131 being applied to the prepared shaft ,
- * In-situ machining of the Belzona® 1131 being carried out ,
- * The completed application ,

Application was carried out in accordance with Belzona System Leaflet MPT-1. Portable lathe was used to machine shaft in place without removing or complete dismantling.
