# BELZONA IN-SITU REBUILD OF DECK WINCH

ID: 103

Shaft of deck winch

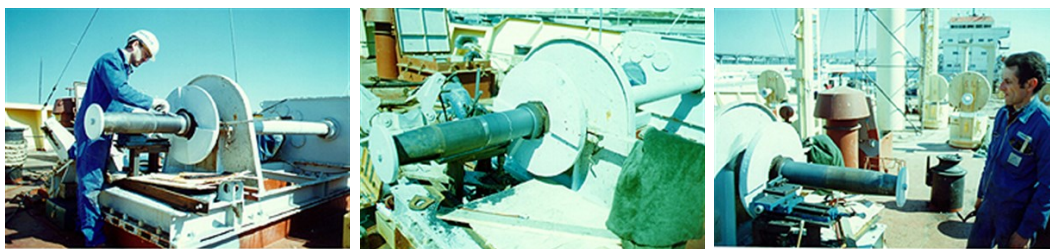
*Wear on shaft was in the way of the cable drum*

- \* Belzona® 1131 being applied to the prepared shaft ,
- \* In-situ machining of the Belzona® 1131 being carried out ,
- \* The completed application ,

Application was carried out in accordance with Belzona System Leaflet MPT-1. Portable lathe was used to machine shaft in place without removing or complete dismantling.
