# Stopping Damage and Cutting Heat: Belzona's Dual Approach to Reactor Repair

ID: 10300

Industry: Chemical & Petrochemical  
Application: TCC-Tanks and Chemical Containment Areas  
Substrate: Other  
Products: Belzona 1511 (Super HT-Metal), Belzona SuperWrap II, Belzona 5871

Customer Location: Kidderminster  
Application Date: November 2025

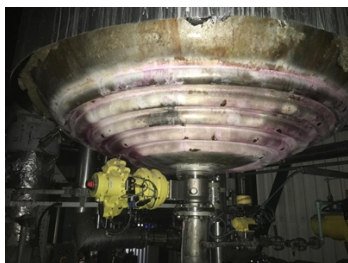
Corrosion around the heating elements of 316L stainless steel acrylic reactors caused through-wall defects and live leaks. A local sales engineer from Belzona UK Ltd has visited the site and demonstrated leak sealing for through-wall defects using Belzona 1511. This repair has been successful and is performing well. However, new weak areas within the reactor have now penetrated the steel, leading to additional live leaks.

Stainless steel acrylic reactors showing signs of corrosion and through-wall defects

Previous repairs to the reactors had been successful and were performing well. However, new weak areas within the reactor had penetrated the steel, leading to additional live leaks. Belzona UK were requested to propose a long-term solution, along with offering a cool-to-touch solution to reduce risk of contact burns.

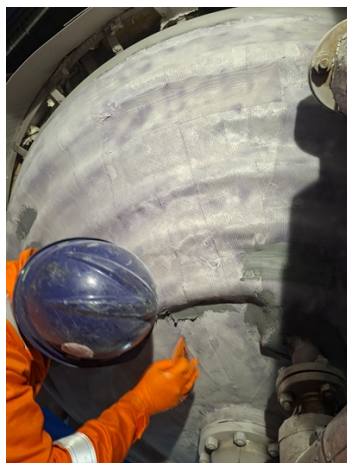
Belzona SuperWrapII system applied to reactor

Once leaking areas were identified and marked, the surface was grit blasted to achieve the required substrate cleanliness standard SA 2½ and a minimum profile of 75µm.

All substrate defects within the area are repaired using Belzona 1511 (Super HT-Metal), including surface reprofiling and filleting where necessary.

Belzona SuperWrap II system was then applied over the entire area in three layers with a 50/50 overlap design, before wrapping with consolidation tape.

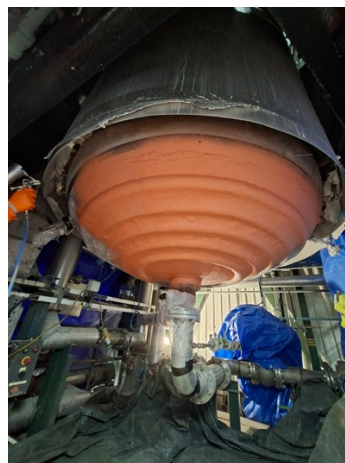
Belzona 5871 is spray applied on top of Belzona SuperWrapII system

Finally, Belzona 5871 is applied. Belzona 5871 is a thermally insulating coating, providing protection against contact-burn injuries, whilst also eliminating corrosion and problems associated with Corrosion Under Insulation (CUI), resulting in improved safety, durability and efficiency.

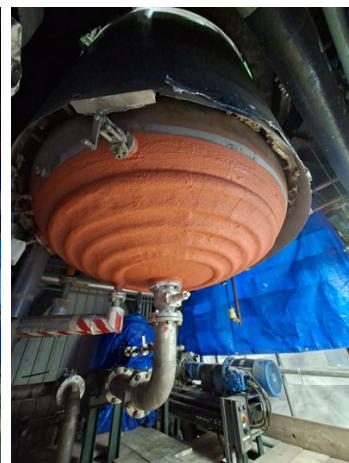
Completed application has solved corrosion issues, offered long-term protection and reduced risks of contact burns

The integrity of the reactor was restored, offering long term protection against the effects of corrosion under insulation. The cool-to-touch solution also reduces heat on metallic substrates to below 60°C, eliminating risks of contact-burn injuries.
