# Belzona Protection of 180 Stay Vanes and Nearly 200 m<sup>2</sup> Bottom Water Guide against Erosion-Corrosion

ID: 10303

Application: CEP-Centrifugal Pumps

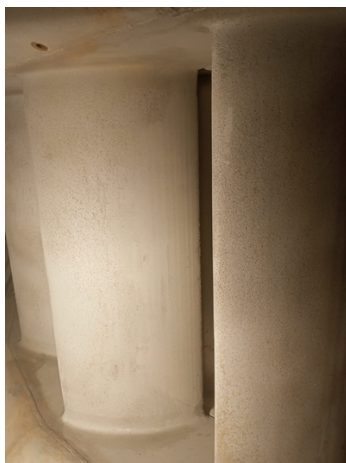
At a hydroelectric power plant in India with a generating capacity of 400 MW, the stay vanes and bottom water guide area of the hydro-turbine were suffering severe erosion-corrosion damage. The customer had previously relied on an epoxy coating system, but it delivered under-rated performance, poor adhesion, and inadequate erosion-corrosion resistance. The earlier coating also had to be reapplied during every shutdown for the last 4–5 years, so it did not deliver the expected service life or long-term protection.

Hydro-turbine were suffering severe erosion-corrosion damage

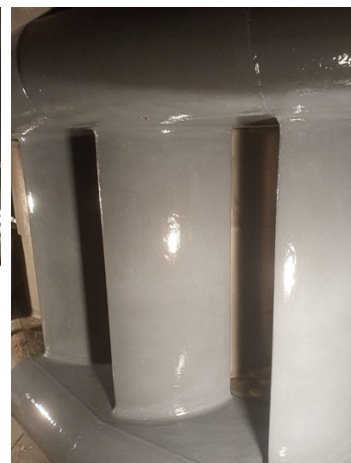
Application of Belzona protective system

Closer view on the hydro-turbine after the application of Belzona solution for erosion-corrosion resistance

After blasting, the areas were cleaned and degreased thoroughly. Belzona 1311 (Ceramic R-Metal) was specified to rebuild and reclaim the worn and pitted areas, followed by the application of the Belzona 1321 (Ceramic S-Metal) as a protective coating to resist erosion-corrosion and extend the service life of the equipment.
