# Flange face repairs

ID: 10305

Industry: Chemical & Petrochemical  
Application: VPF-Valves, Pipes and Fittings  
Substrate: Carbon steel  
Products: Belzona 4301 (Magma CR1 Hi-Build), Belzona 9411 (Release Agent)

Customer Location: Scotland  
Application Date: July 2025

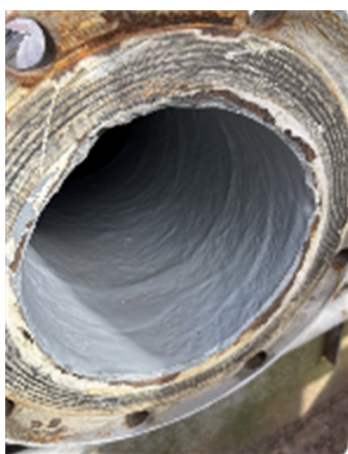
Several flanges had become corroded through contact with inorganic acids. A chemical resistant rebuilding material was required to bring these flanges back into a serviceable condition. The acid content & temperatures of these tanks varied during service, for the most assurance Belzona 4301 was selected.

Damaged flange

The existing material was removed using angle grinders. The metal substrate was then prepared using MBX Bristle Blasters. Flange face formers were then used with Belzona 9411 release agent to rebuild the Belzona 4301 to the required dimensions on the flange.

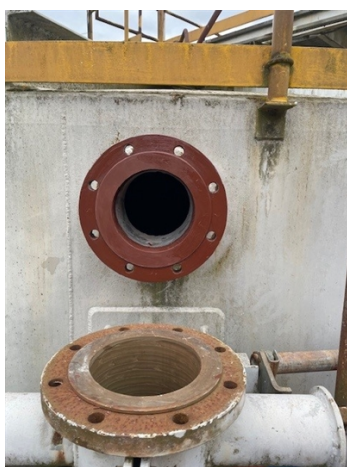
Flange rebuilt with Belzona 4301

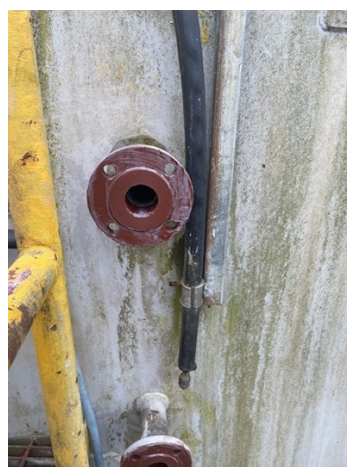
Flange rebuilt with Belzona 4301

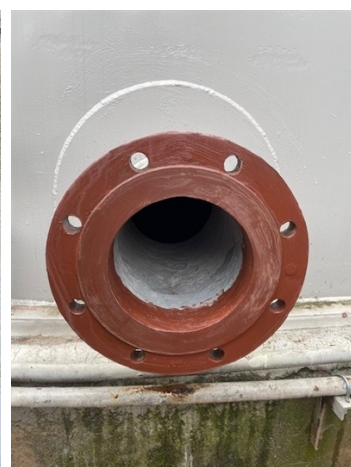
Flange rebuilt with Belzona 4301
