# Vacuum Steam Pipework repairs with Belzona SuperWrap II

ID: 10306

Industry: Chemical & Petrochemical

Application: VPF-Valves, Pipes and Fittings

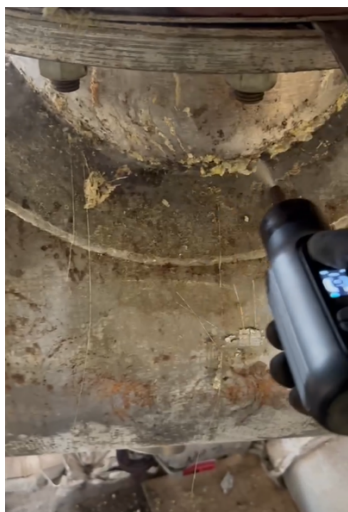
Through wall defects had appeared in the low pressure steam system. These defects were around flanges & tee pieces. The geometry meant traditional repair methods would be very challenging. The thin wall of the pipe ducting meant welding was out of the question.

Close up of leaking areas

The defective areas were first prepared to SSPC-SP11 using an MBX Bristle Blaster. Belzona 1511 HT Metal was used to fair any defects. Belzona 1983 Superwrap II was then applied as a patch system to reinforce the defects.

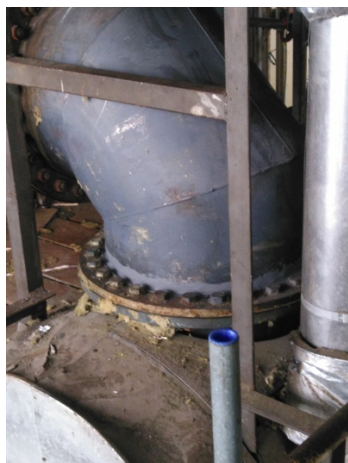
Leaks around flange

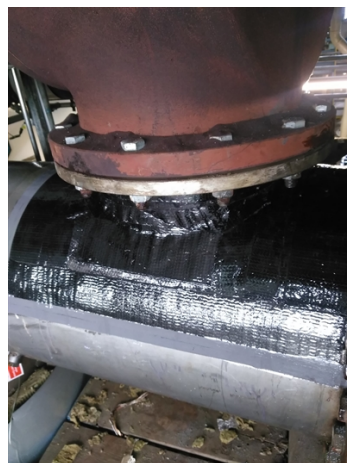
Completed repairs

A x4 wrap system was used for the repairs. The system was applied on a standard basis.
