# Belzona Extends the Life of the Heat Exchanger

ID: 10307

Industry: Power  
Application: HEX-Heat Exchangers  
Substrate: Cast Iron  
Products: Belzona 1321 (Ceramic S-Metal)

Customer Location: Croatia  
Application Date: March 2011

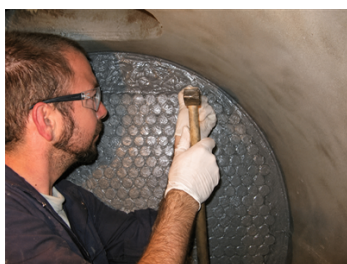
Protection of Belzona 1321 on heat exchanger

To prevent the coating from blocking the tube openings, custom-fit plugs were inserted into each tube end. Belzona 1321 (Ceramic S-Metal) was then mixed and applied onto the tube sheet face to create a seamless, erosion-resistant shield. The plugs were carefully removed before the polymer fully cured, leaving clean, sharp, and unobstructed edges at the tube entries.

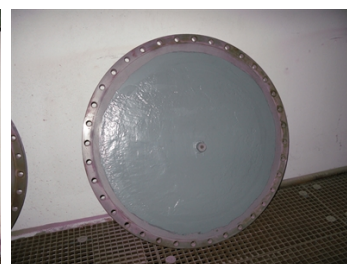
Finished application of Belzona 1321 on heat exchanger end cover
