# Belzona repairs and reinforces leaks in gas threaded pipes

ID: 10314

Application: VPF-Valves, Pipes and Fittings

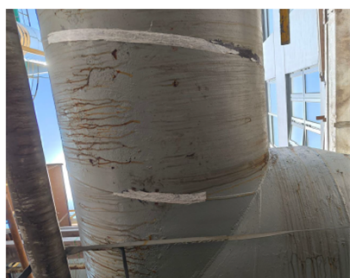
There are sand holes at the base of the threaded pipe at the inlet to the drum cooler, resulting in a slight gas leak. The circumferential welded seam of the threaded pipe requires reinforcement and protection. The pipe is a negative-pressure pipe with a diameter of 1.4 metres and operates at ambient temperature.

Leaking pipe with sand holes

Seal the sand holes with Belzona 1212, then rebuild the entire circumference of the weld seam with Belzona 1111. Finally, use the Superwrap II system to reinforce the pipeline as a whole.

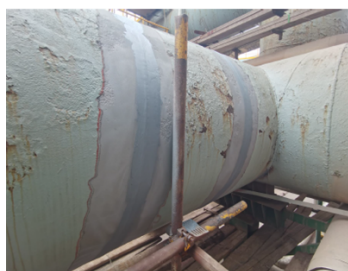
Application of Belzona 1212 and Belzona 1111

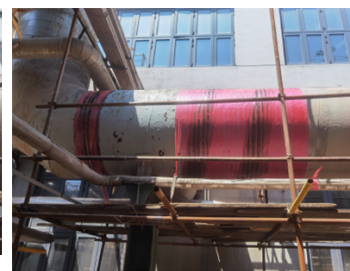
Application completed

Superwrap II system restores the integrity of the pipeline and reinforces it, providing long-term protection for the equipment.
