# Cold-Cure Rebuild of a Corroded Marine Propulsion Shaft

ID: 10315

Industry: Marine  
Application: MPT-Mechanical Power Transmission

Substrate: Carbon steel  
Products: Belzona 1111 (Super Metal)

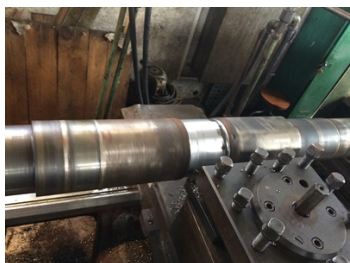
Damaged shaft

During an inspection of, heavy localized corrosion was discovered on the carbon steel propulsion shaft. The damage was situated exactly at the seal journal—the critical interface that maintains a watertight barrier between the ocean and the vessel's interior. If this corroded profile were left unaddressed, it would inevitably tear the seal, leading to seawater ingress into the hull. The vessel owner required a rapid, reliable solution to prevent a catastrophic leak without incurring the massive costs associated with prolonged dry-docking.

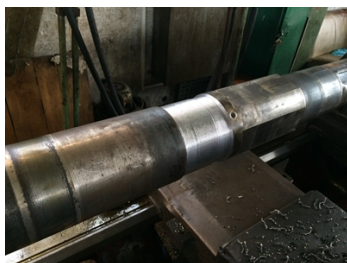
Surface preparation

The shaft was extracted and mounted onto a lathe for a precision repair. To prepare the area, the corroded seal journal was undercut via machining to remove the damaged metal, and the surface was thoroughly roughened to ensure an optimal mechanical grip for the repair composite.

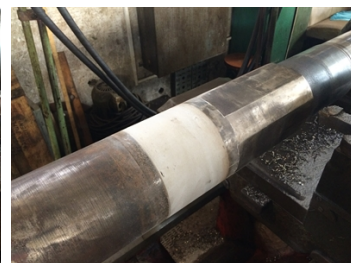
Application finished

While the lathe rotated at a very low speed, Belzona 1111 was applied. To prevent air entrapment and ensure maximum adhesion, the first layer was aggressively scrubbed into the roughened profile using a short-bristled brush. The composite was then built up in thin, consecutive layers until the outer diameter slightly exceeded the shaft's original dimensions. Once the Belzona 1111 had fully cured, the shaft was machined back down to the exact OEM tolerances and given a final polish with emery cloth to ensure a perfect mating surface for the new seal.
