# Nickel Smelter Intercooler Refurbishment

ID: 10316

**Industry:** Mining & Quarrying  
**Application:** HEX-Heat Exchangers  
**Substrate:** Carbon steel  
**Products:** Belzona 1511 (Super HT-Metal), Belzona 1523

**Customer Location:** WA, Australia  
**Application Date:** November 2022

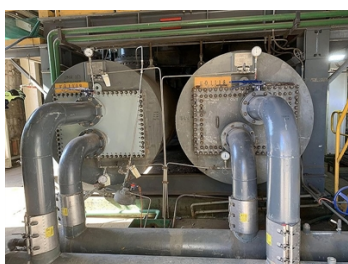
Nickel smelter intercoolers in need of repair

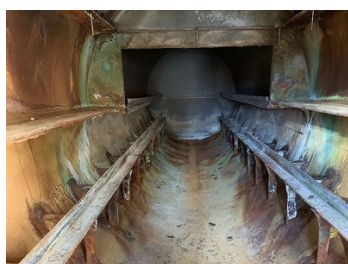
Two intercoolers at a nickel smelter had suffered severe corrosion, resulting in a near-total loss of coating integrity and requiring refurbishment. The corrosion assessment identified extensive coating failure and significant corrosion of the main shell and internal components, including the cooling system support rails.

Significant corrosion of the main shell and internal components.

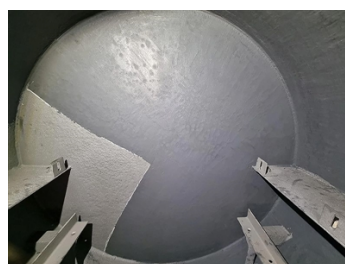
Pit filling and metal repairs undertaken with Belzona 1511.

First, pit filling and metal rebuilding were undertaken using Belzona 1511 (Super HT-Metal), a high-temperature repair composite for metal restoration and corrosion protection, applied extensively to the intercooler shells to address widespread pitting and substrate loss.

Once the substrate was adequately prepared and all significant metal loss rebuilt, all welds and hard-to-reach areas were stripe coated.

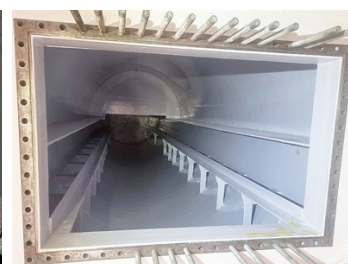
Final application of Belzona 1523 applied to the intercoolers.

This was followed by the spray application of two coats of Belzona 1523, a high-temperature, corrosion- and chemical-resistant coating, to a minimum dry film thickness (DFT) of 500 µm using a heated-line mobile spray unit.
