# Chemical Factory Mezzanine

ID: 10317

**Industry:** Chemical & Petrochemical  
**Application:** WPA-Wall Problem Areas  
**Substrate:** Carbon steel  
**Products:** Belzona 5811 (Immersion Grade)

**Customer Location:** Auckland  
**Application Date:** July 2026

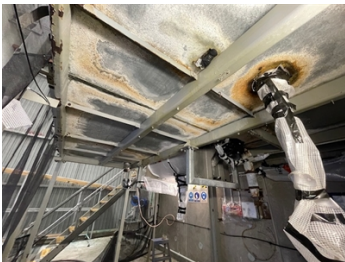
The underside of this mezzanine loading platform was suffering from corrosion, brought on by exposure to caustic soda and water during wash-down cycles. If left unchecked this corrosion would have eventually compromised the structural integrity of the platform resulting in HSE issues and expensive repairs. As the client was reluctant to shut down the area for more than 5 days, large scale, conventional repair work would not have been possible without unacceptable production loss.

Original condition of the underside of the mezzanine, showing corrosion and chemical deposits

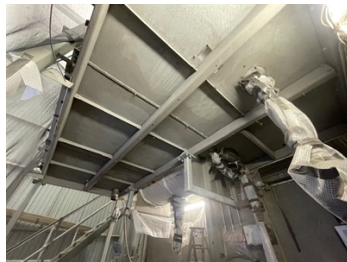
Grit Blasted to SA2.5 and around 100 microns of profile using sponge blast garnet.

Sponge blasting was used to reduce dust which would have impacted negatively on the rest of the facility, this took two days to complete, including cleaning once finished. Over the following two days, two coats of Belzona 5811 (Immersion Grade) were applied at around 250 microns per coat, using brushes for the first coat and rollers for the second.

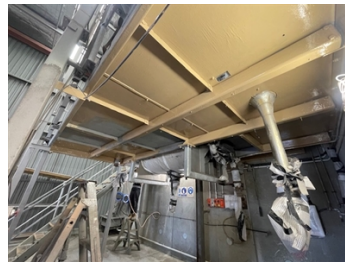
Midway through the first coat of Belzona 5811 (Immersion Grade), which was applied with a short-bristled brush to take full advantage of the profile

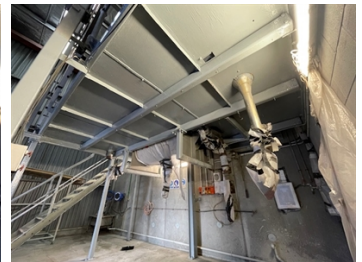
The completed two coat system with a DFT of 400 - 450 microns
