# 151 pipe elbows refurbished and protected against abrasion using 1.5 tonnes of Belzona 1812

Industry: Power  
Application: SHM-Solids Handling Machinery  
Substrate: Cast Iron  
Products: Belzona 1812 (Ceramic Carbide FP)

Customer Location: Southwestern Croatia  
Application Date: June 2024

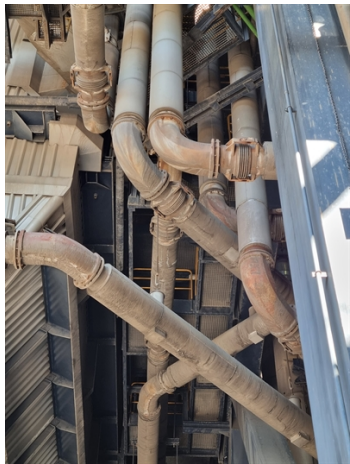
Pipework leading from the coal mill to the burners.

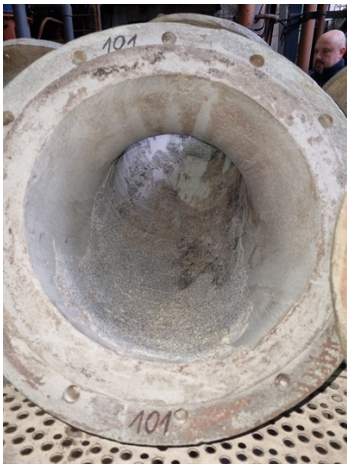
Pipe elbow showing remnants of the previous Belzona 1812 application.

The customer selected Belzona primarily due to their positive previous experience with the system. As shown in Picture 2, after a minimum of 12 years in service following the original application, remnants of the previous Belzona 1812 lining were still present on some pipe elbows and could not be removed by abrasive blasting. After two years in service following the 2024 application, feedback from the customer confirmed that no external issues were observed during the annual turnarounds in 2025 and 2026. As a result, dismantling and detailed internal inspection were not required.

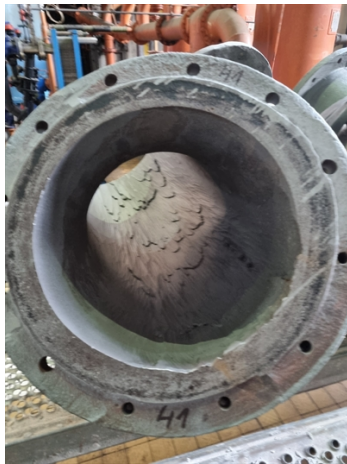
One of the most severely damaged pipe elbows before application.

The application was carried out in accordance with Belzona Know-How System Leaflet SHM-8. The surfaces were abrasive blasted, degreased and dedusted in accordance with the Belzona 1812 Instructions for Use. Belzona 1812 was then applied using Belzona

application tools to rebuild the worn areas and provide an additional 3 mm layer of abrasion protection.

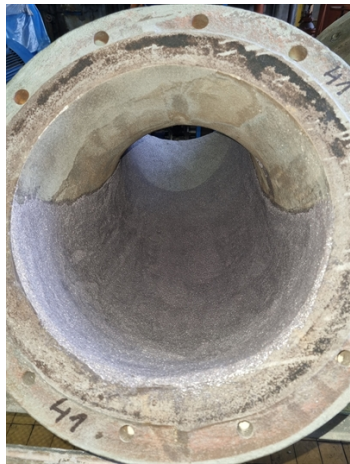
Pipe elbow after application of Belzona 1812.
