# Belzona repairs concrete wall suffering from biomass abrasion

| Industry: | Power | Customer Location: | Centro de Portugal |
| Application: | WPA-Wall Problem Areas | Application Date: | June 2026 |

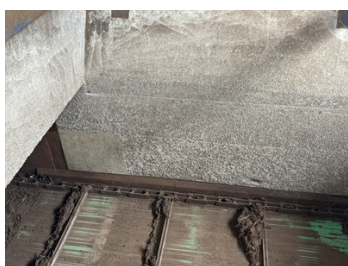
*This concrete wall is part of a biomass conveying system that feeds the boiler used for electrical power generation. Over the years, the wall has progressively worn down due to the abrasion caused by the transport of wood branches and logs. In 2019, we carried out a trial on an area of approximately 1 m<sup>2</sup>, which can be seen in the first photo on the left. The conveyor continued operating for almost seven years, during which the customer confirmed the excellent performance of the test area. As a result, they decided to request a quotation for the treatment of the entire lower half of the walls, in order to prevent the deterioration from spreading further.*

Condition of the structure prior to the repair work.

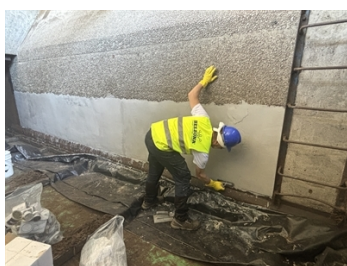
Application of Belzona 4111 (Magma-Quartz).

The work procedure consisted of cleaning the walls with high-pressure water jetting, which was carried out by the customer. Two days later, we began our part of the project by applying Belzona 4911 Magma TX Conditioner, followed by rebuilding and resurfacing with Belzona 4111 Magma-Quartz.

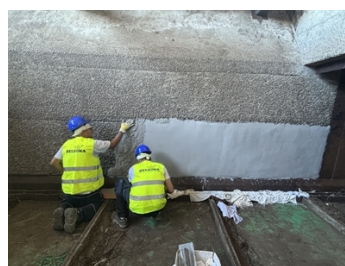
Application of Belzona 4111 (Magma-Quartz).

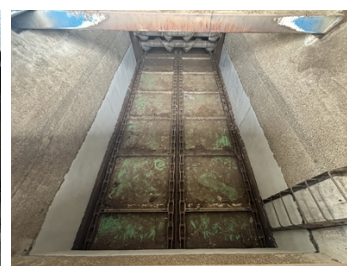
Work successfully completed.
