# Abrasion protection of slag dosing cyclones and pipework at a cement plant with Belzona 1813

ID: 10322

Industry: Cement  
Application: SHM-Solids Handling Machinery

Customer Location: Southern Croatia  
Application Date: April 2026

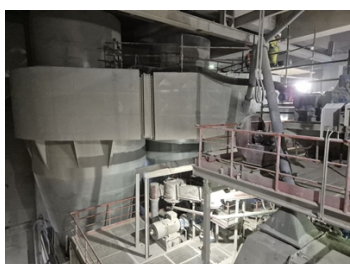
Ground slag added to cement clinker was causing severe abrasive wear inside the separator cyclones and associated pipework. Continuous material flow gradually reduced the steel wall thickness, increasing the risk of breakthrough and unplanned shutdowns between scheduled annual maintenance intervals.

Slag dosing cyclones and connected pipework from the outside.

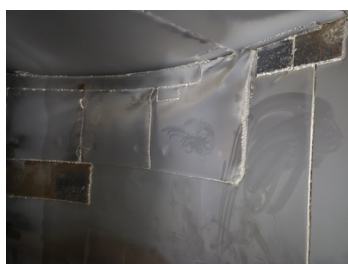
Customer-repaired area with welded steel plates before Belzona application.

The customer required a reliable sacrificial lining to control abrasion and extend the service life of the equipment until the next planned annual turnaround. Prior to the Belzona application, the customer repaired the most damaged and perforated areas in-house by welding steel plates over the affected sections. Due to the abrasive nature of the conveyed slag and a maximum operating temperature of 120°C, Belzona 1813 was selected as the most appropriate solution. In total, 500 kg of Belzona 1813 was used to protect the most exposed areas.

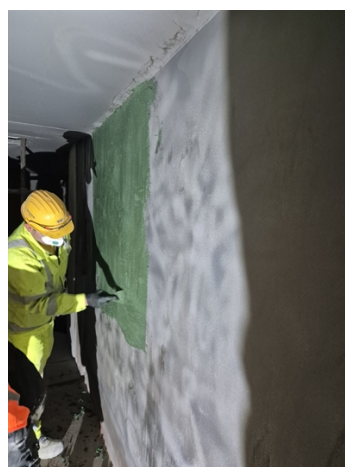
Belzona 1813 application in progress

The application was completed in accordance with Belzona Know-How System Leaflets SHM-8, SHM-13 and the Belzona 1813 Instructions for Use. Following the customer's mechanical repairs to the damaged sections, the steel substrate was abrasive blasted, degreased and thoroughly dedusted prior to application. Belzona 1813 was then applied at a uniform thickness of 3 mm using Belzona application tools and masonry spatulas, creating a continuous abrasion-resistant barrier over the cyclone and pipework surfaces.

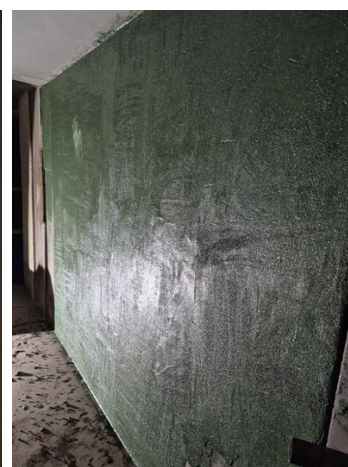
One affected area after Belzona 1813 application.
