# Belzona repairs and protects the tank foundations of numerous storage tanks

ID: 10324

| Application: | FPA-Floor Problem Areas | Application Date: | November 2025 |

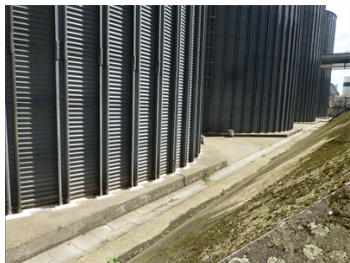
The concrete foundation of the storage tank had structural issues. Because the concrete was highly porous and sloped towards the tank, water regularly collected around the base and soaked into the old concrete. Over time, this moisture found its way into the tank, causing the stored seed material to clump together into a hard, concrete-like mass. This aggressive material then started attacking the inside surfaces of the tank, leading to increasing damage.

Tanks before the application

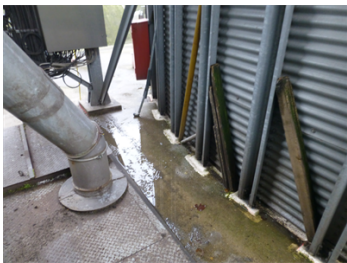
Condition of the problem areas

In 2005, the first tank foundation was repaired with Belzona 4111 and protected with Belzona 3111. Twenty years later, in 2025, the customer found that the products were still well bonded to the substrate. However, increasing moisture penetration and continued deterioration of the old concrete had made the underlying structure unsuitable for long-term service.

To repair the foundation, the old waterproofing layer was first completely removed and the concrete surface was abrasive blasted. Temporary formwork was then installed to create a new slope, and the areas were primed with Belzona 4911 before being rebuilt with Belzona 4111. After the formwork was removed, the remaining areas and the upstand around the base were filled and smoothed. The surface was then blasted again and thoroughly cleaned. Finally, the foundation was treated with Belzona 3921 conditioner and coated with Belzona 3111, reinforced with Belzona 9311 reinforcement sheet, to provide a durable, long-lasting waterproof seal.

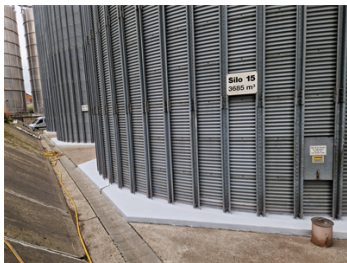
All tank foundations repaired and protected with Belzona 3111
