# Belzona Super Wrap II saves a severely corroded manifold

ID: 10325

**Industry:** Food & Drink  
**Application:** VPF-Valves, Pipes and Fittings  
**Substrate:** Carbon steel  
**Products:** Belzona 1511 (Super HT-Metal), Belzona 1983 (SuperWrap II), Belzona 9111 (Cleaner Degreaser)

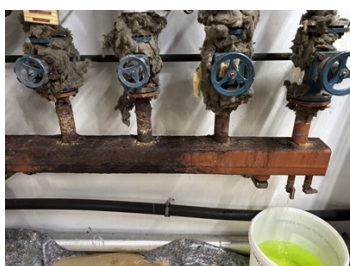
The manifold was insulated but had not been inspected for many years. During an inspection, severe corrosion was discovered, with deep pitting in several areas and even through-wall holes that were causing water leaks. An urgent repair was required to stop the leaks, restore the strength of the manifold, and provide long-term protection.

Corroded manifold

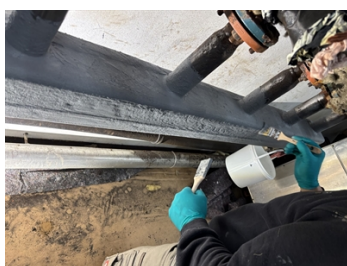
Substrate repaired using  
Belzona paste-grade materials

The substrate was then repaired using Belzona 1511 in combination with Belzona 9341, which was used to seal the holes and rebuild the damaged areas. Once the substrate had been restored, the entire manifold was wrapped and reinforced with Belzona Super Wrap II. The repair was then consolidated using Belzona 9382, resulting in a fully sealed and long-lasting repair after curing.

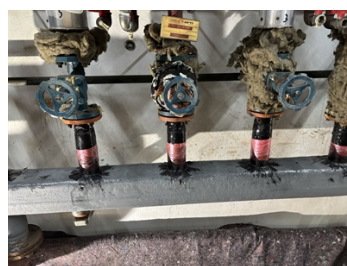
Start of the Super Wrap II  
application

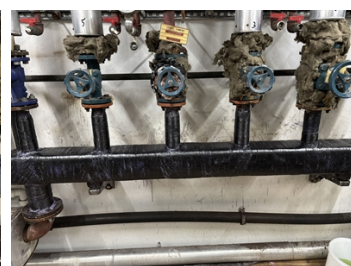
Completed repair

Belzona provided a cost-effective repair solution with minimal downtime, allowing the severe corrosion damage on the manifold to be addressed quickly and efficiently. The Super Wrap II system restored the manifold's structural integrity and significantly extended its service life.
