# Turbine components repaired with Belzona

ID: 10327

| Application: | CEP-Centrifugal Pumps | Application Date: | June 2026 |

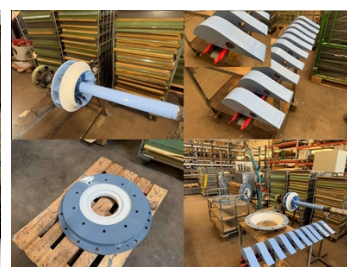
The fully repaired and coated turbine components.

The water-facing surfaces of the runner, shaft, and guide vanes were coated with Belzona 1341 to provide long-term protection against erosion and wear. For the internal and external surfaces of the turbine covers, as well as the regulating ring, Belzona 5821 was applied as a protective coating.
