# Belzona Custom Engineered Solution Reduces SF<sub>6</sub> Emissions from Critical 132kV Junction

ID: 10330

Customer Location: Pontefract  
Application Date: July 2026

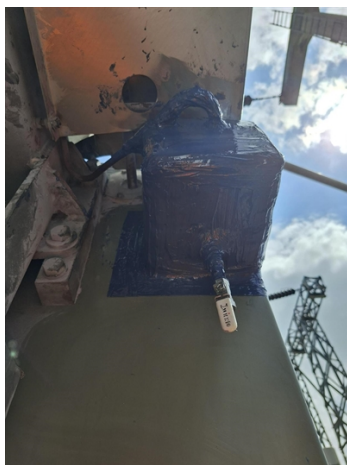
A bespoke containment box was fabricated to fit around the junction

Existing repair materials were removed and the substrate prepared accordingly. A bespoke Belzona composite containment box was fabricated and secured around the leaking fitting, incorporating a vent pipe to allow controlled venting during installation. Once in position, Belzona 7311 was injected into the void space to completely fill the cavity and eliminate any trapped air that could create

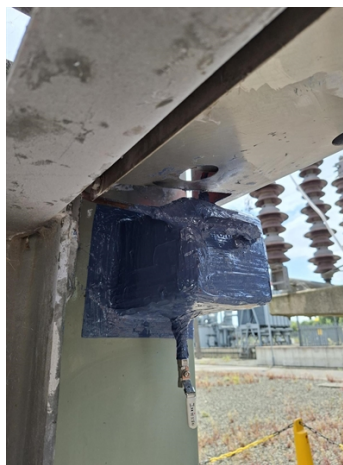
Belzona 7311 was injected into the void space to completely fill the cavity and eliminate any trapped air

potential leak paths. Following cure, a full inspection was carried out the next day before sealing the vent pipe to complete the repair installation.

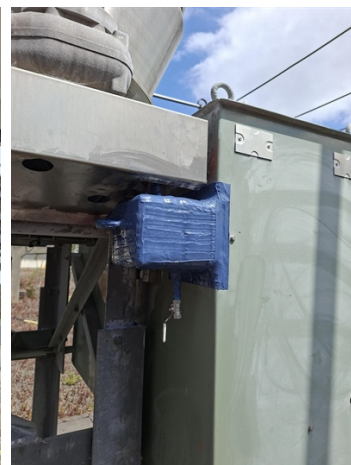
Significantly reduced, and where possible eliminated, SF<sub>6</sub> gas emissions from the leaking junction.
