# Reptech Repairs and Recoats a Hot Water Process Tank with Belzona

**Customer Location:** Fonterra Lichfield, state highway 1,  
Lichfield 3482

**Application:** TCC-Tanks and Chemical Containment  
Areas

**Substrate:** Carbon steel

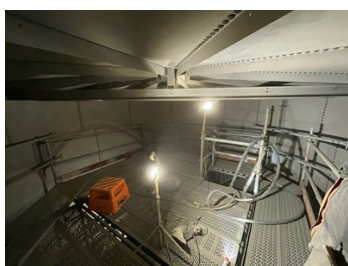
Steel grit was used to ensure efficient removal of the original glass-flake coating and hot air was pumped into the tank to ensure favourable ambient conditions overnight, holding the blast at SA 2½

The entire tank was scaffolded and abrasive blasted using steel grit to achieve a SA 2½ blast standard with a surface profile of 75 microns. The ambient conditions and blast standard inside the tank were maintained using a heater, which kept the relative humidity below 40% and the temperature at approximately 25°C.

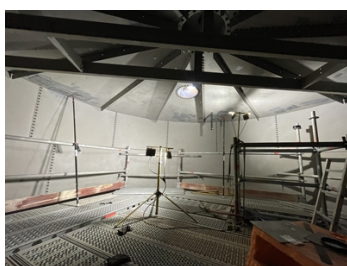
Holes and pitting were repaired with Belzona 1111 (Super Metal), Belzona 9341 and doubler plates.

All holes and defects were repaired using either blasted steel plates or Belzona 9341 reinforcement tape, depending on the size of the defect, in conjunction with Belzona 1111. Belzona 5892, selected for its high-temperature resistance and potable water certification, was then spray-applied in accordance with the specification over the entirety of the tank walls and roof.

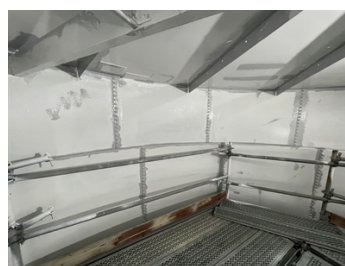
The first coat of Belzona 5892 white was spray applied; complex geometries received a Belzona 5892 Grey stripe coat the following morning (well within the overcoat window). As soon as this was completed a topcoat was sprayed in B5892 Grey.

Stripe coats were applied as soon as the first coat had sufficiently stabilised. A second coat of Belzona 5892 Grey was then spray-applied over the entirety of the walls and roof. Following post-cure, the coating was spark-tested, and any remedial work was carried out in accordance with the specification.
