# Belzona Rehabilitates Concrete Distribution Chambers in an Odour-Covered Inlet Channel

| Industry: | Water / Wastewater | Customer Location: | Yorkshire |
| Application: | TCC-Tanks and Chemical Containment Areas | Application Date: | April 2021 |

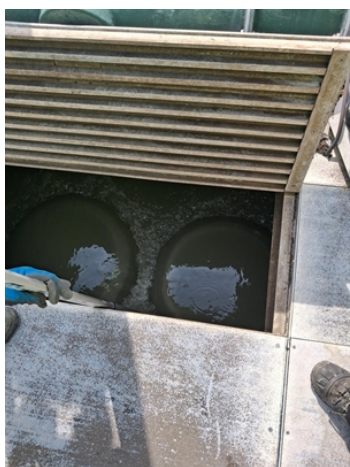
The tanks were covered as part of an odour control strategy

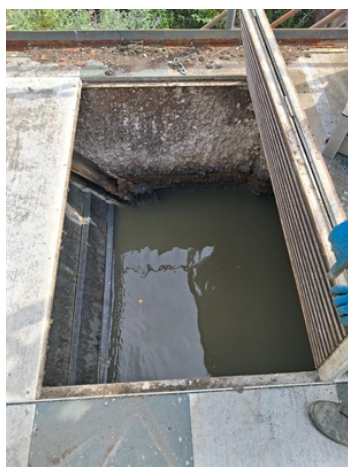
The damage had progressed to the point where the aggregate was exposed across multiple areas of the channel walls and surfaces. This level of degradation increased the risk of accelerated concrete loss, continued chemical attack, and reduced structural integrity if left untreated. Surveys identified an average substrate loss of approximately 20mm across both chambers, with repair depths extending up to 1.35m from the top surface of the chamber structure.

Deterioration of the tanks had continued under the covers and required a repair solution

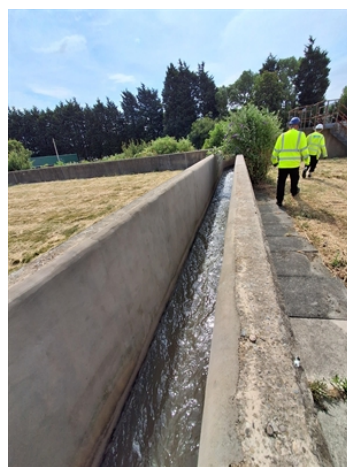
damaged areas were then rebuilt using a combination of bulkfill material and Belzona 4131 Magma Screed

Following drainage and surface preparation, all weakened concrete and exposed aggregate were removed to create a sound substrate for repair. The damaged areas were then rebuilt using a combination of bulkfill material and Belzona 4131 Magma Screed, restoring the original concrete profile while providing excellent durability and chemical resistance.

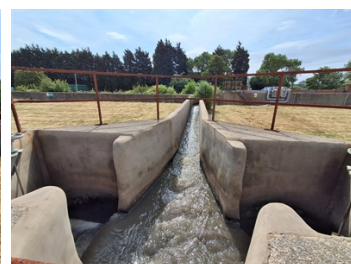
The repairs provided a durable, chemically resistant repair capable of withstanding the harsh wastewater environment.

Belzona 4131 Magma Screed restored the damaged concrete profile, providing a durable, chemically resistant repair capable of withstanding the harsh wastewater environment.
