# Floating Dock Repair using Belzona 4141 Magma-Build

ID: 10346

Application: WPA-Wall Problem Areas

Substrate: Concrete

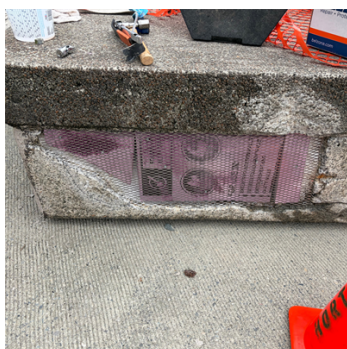
Steel mesh installed to provide backing for concrete rebuild.

The damaged concrete was cleaned and abraded using a Bristle Blaster to achieve a sound, mechanically profiled surface, and any cracks were v-grooved out to provide a solid key for the repair material. Expanded steel mesh was secured to the sound surrounding concrete to serve as a backstop for the rebuild. Belzona 4911 (Magma TX Conditioner) was applied to both the concrete and steel substrates to promote adhesion, followed immediately by Belzona 4141 (Magma-Build), which was built up in layers to match the original profile of the dock. All work was performed in accordance with Belzona's Instructions for Use (IFU's).

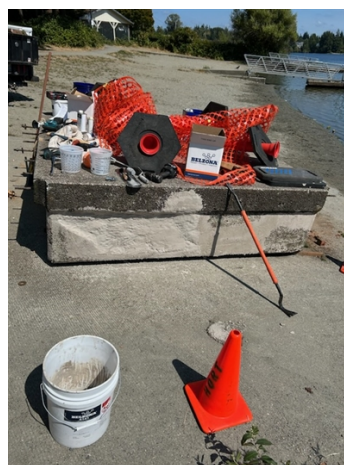
Floating dock during application.

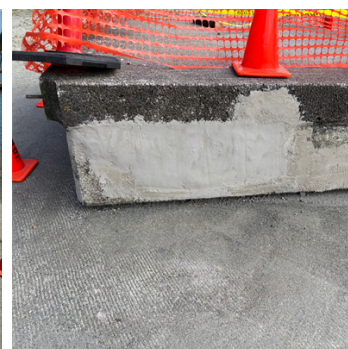
Finished application.

The high build capability of Belzona 4141 (Magma-Build) allowed the City to rebuild the damaged section in place on a vertical surface without the cost and downtime of a full dock section replacement.
