# Sulfuric Acid Requires A Belzona Solution

ID: 10347

**Industry:** Steel & Metal Processing  
**Application:** VPF-Valves, Pipes and Fittings  
**Substrate:** Carbon steel  
**Products:** Belzona 4311 (Magma CR1)

**Customer Location:** Sand Springs Oklahoma  
**Application Date:** August 2026

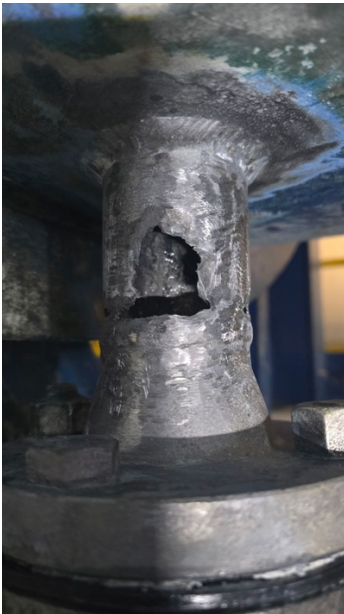
A 6" long 2" nozzle on the bottom of the sulfuric acid tank had developed a 1" hole in the middle on one side. The tank was immediately drained and the customer needed a repair solution that was quick and reliable. The customer has a history of using Belzona materials in other areas, so we were brought in to find a solution.

The damaged nozzle.

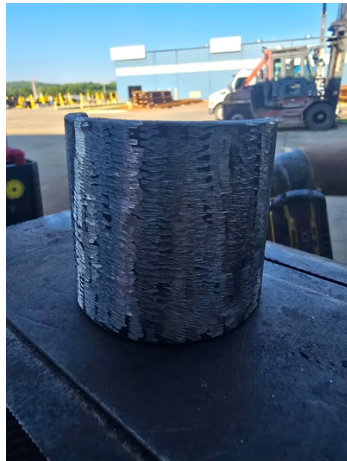
Prepped sleeves to be used to bond over the hole. They were bonded into place using Belzona 4311.

The sulfuric acid was neutralized and rinsed off several times. The surface was prepped using hand tools. First was a wire wheel to remove any loose corrosion or surface contamination. Then a grinder was used to roughen the surface with an irregular profile. This also allowed us to get close to the existing hole without damaging it further. The Belzona 4311 was used to wet out the surface and the doubler saddles. The saddles were positioned for best coverage of the hole and slipped into place. Once aligned, the Belzona 9341 reinforcement tape was thoroughly wetted out and wrapped in multiple layers around the doubler saddles and over the

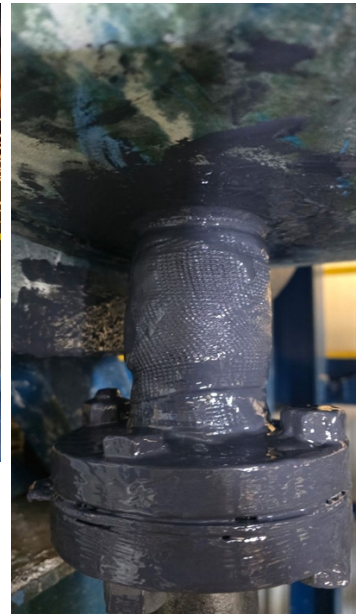
Application complete with multiple wraps of Belzona 9341 reinforcement sheet and Belzona 4311.

length of the nozzle. Excess material was then brushed over adjacent areas as well which had also been prepped in advance.
