# Belzona Saves Refinery Millions

ID: 1039

Customer Location: Oil Refinery - Tuscaloosa, AL USA  
Application Date: February 2008

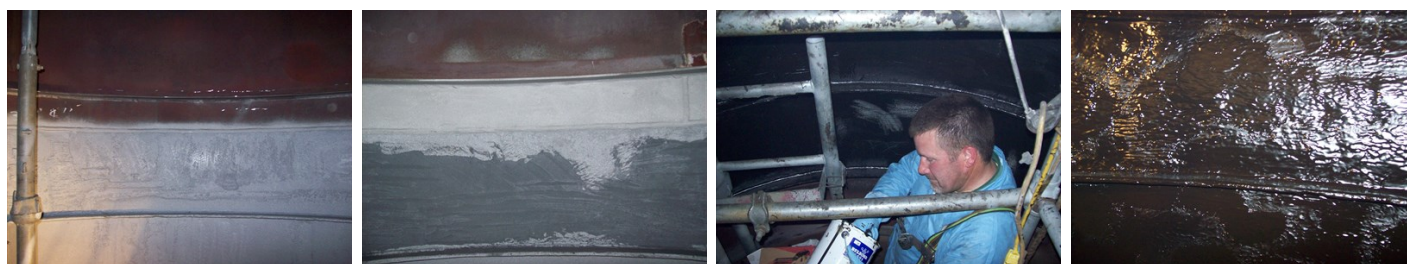
Corrosive process fluids and elevated temperatures create an extremely aggressive corrosion rate. If corrosion was not addressed, this vessel would have gone under its minimum wall thickness and forced a shutdown.

- \* Abrasive blasted area ,
- \* Repaired area with Belzona® 1511 ,
- \* Application of Belzona® 1591 ,
- \* Finished application after pinhole testing ,

Amine regeneration tower operating above 250°F in an environment containing hydrogen sulfide and diglycolamine.

Belzona® 1511 and Belzona® 1591 were applied in accordance with Belzona Know-How System Leaflet TCC-5.

Possible repairs included a Belzona solution or clad welding the affected area. The Belzona solution required less than \$40,000 of product and labor and was completed in three days. The clad welding would have required \$100,000 of product and labor and more importantly 10 days. Because daily lost production costs were \$9,000,000, the Belzona solution saved the refinery over \$63,000,000!
